Deliverable Reference	D 2.2 version 2.0 final
Deliverable Name	Past cases of Extreme Weather Impact on Critical Infrastructure in Europe
Contributing Partners	ESSL as correspondence author
Date of Submission	2015-02-28

Past Cases of Extreme Weather Impact on Critical Infrastructure in Europe

Deliverable: 2.2

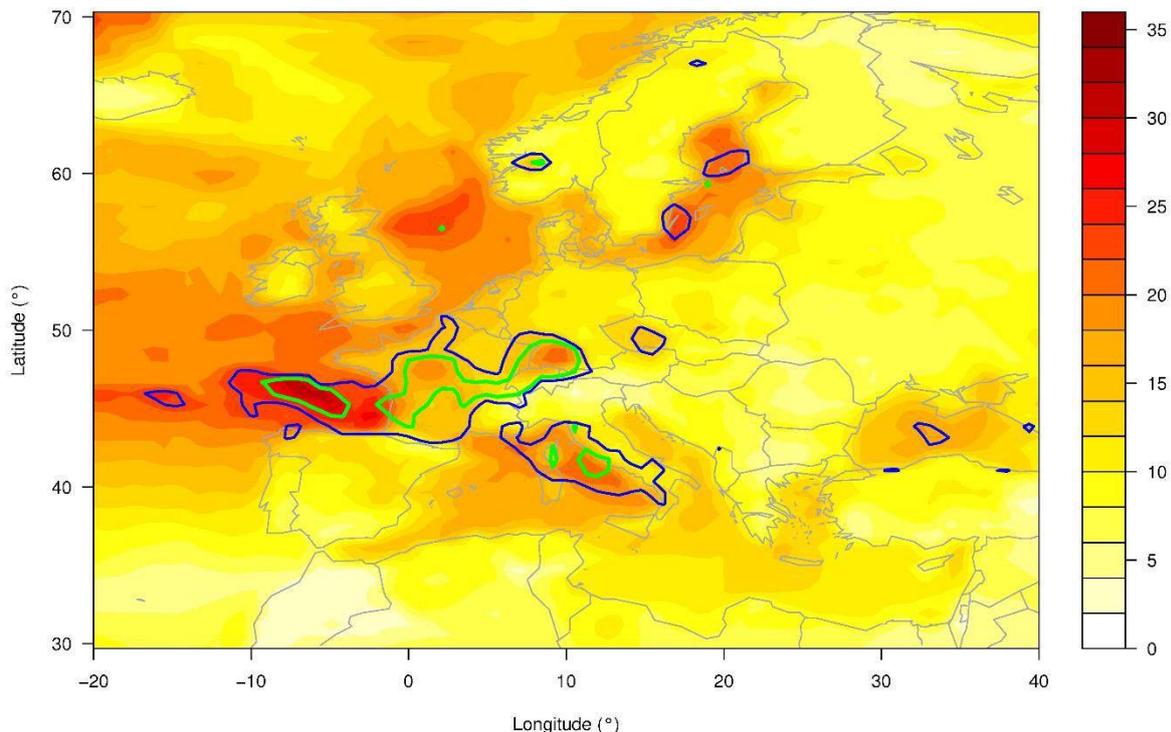
Figure 3.2. Maximum 10m wind speeds in m/s which occurred during the passage of windstorms "Lothar" and "Martin" within the period from 25 to 28 Dec. 1999, derived from ERA interim reanalysis data (shading). The contours encircle areas where the 5-year (blue) and the 50-year (green) return levels are exceeded by the 10m wind speeds

In December 1999 a series of five windstorms affected Europe. The two extreme storms Lothar and Martin occurred within a period of 36 hours and affected mainly Western and Central Europe, in particular France and South Germany (Figure 3.2). These two windstorms had a major impact on the French energy system and caused blackouts affecting 3.4 million people. Lothar and Martin caused 140 fatalities and an economic loss of more than 15 billion dollars (MunichRe 2002).

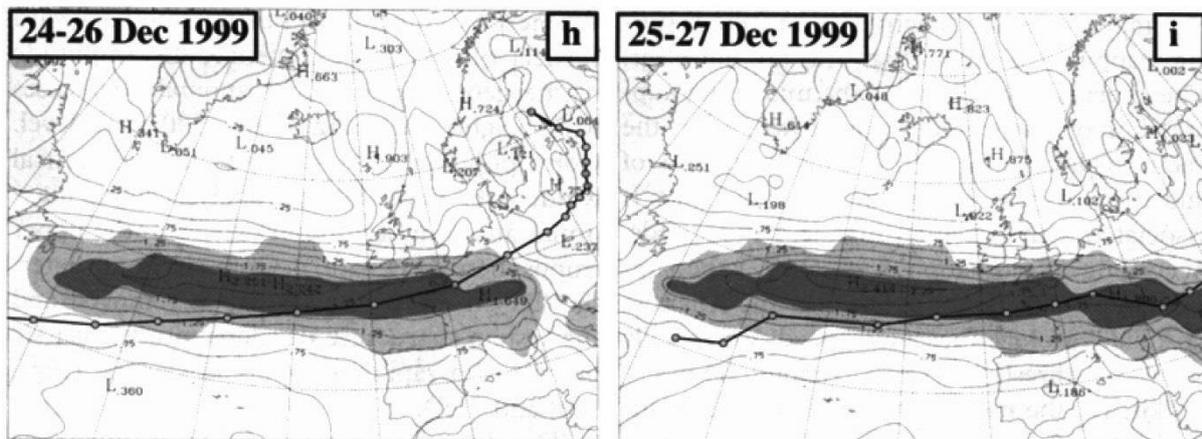
Figure 3.3. Cyclone-tracks of “Lothar” (left) and “Martin” (right) with 6-hourly time steps. Contours show the 3-day averaged upper-level (500 - 300 hPa) Eady growth rate (per day), a measure for baroclinicity quantifying the large-scale conditions for the potential growth of extratropical cyclones. Grid points where the Eady growth rate exceed the local 95th and 99th percentile are shaded. (from Ulbrich et al. 2001)

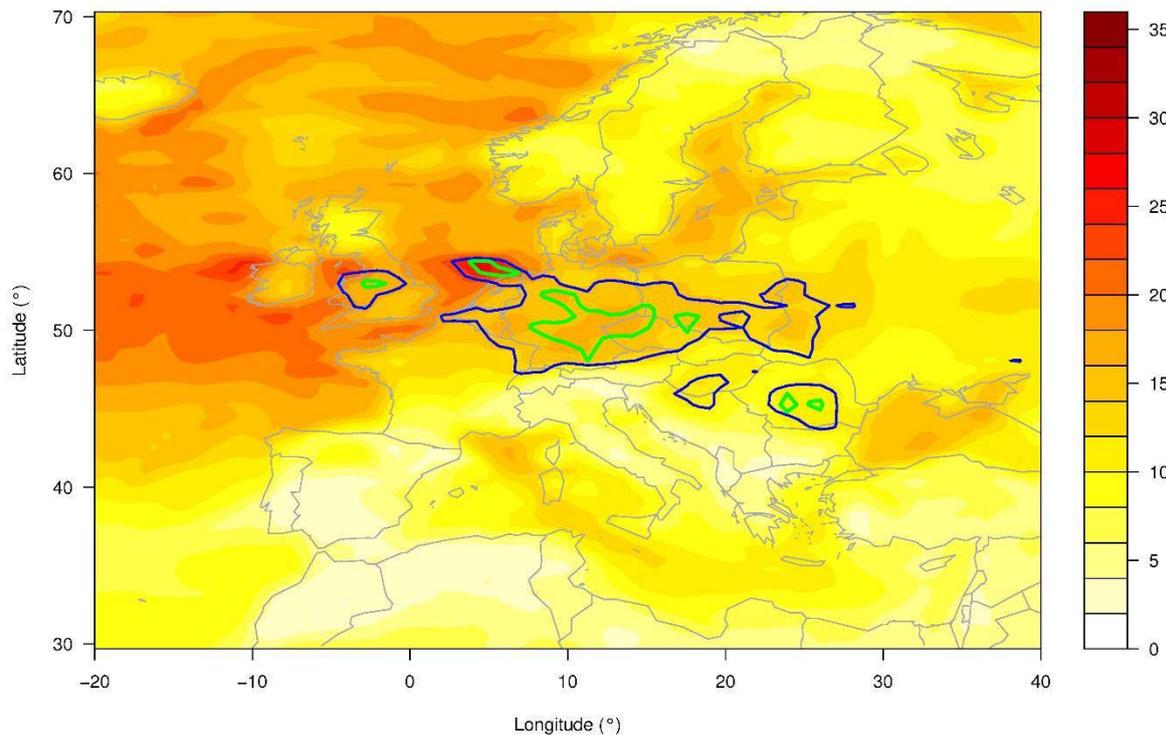
Figure 3.4. Maximum 10m wind speeds in m/s which occurred during the passage of windstorm "Kyrill" within the period from 16 to 19 Jan. 2007, derived from ERA interim reanalysis data (shading). The contours encircle areas where the 5-year (blue) and the 50-year (green) return levels are exceeded by the 10m wind speeds.

Kyrill was an extratropical cyclone which developed into an intense European windstorm in January 2007. It caused extensive damages of up to 7 billion Euros within large parts of Europe (Figure 3.4) and led to 47 fatalities. Kyrill had an exceptionally strong impact on the public transport system and caused widespread power outages.

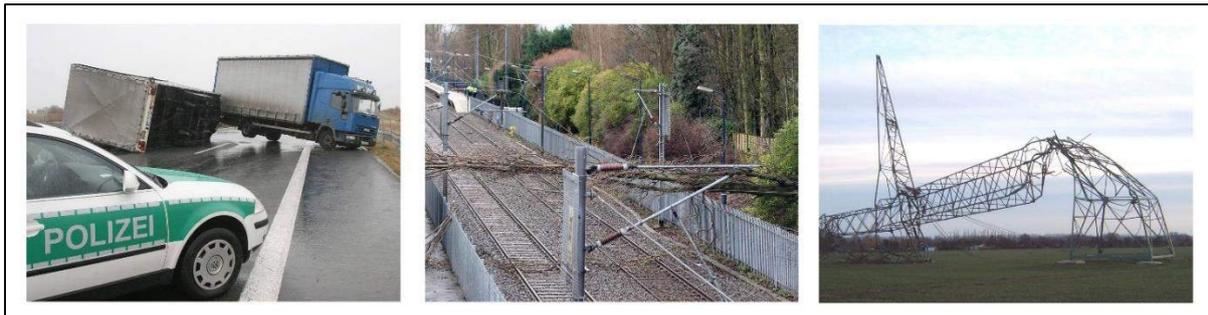
Figure 3.5. Damages caused by the windstorm "Kyrill" between the 18th and 19th January 2007. (from left to right) An overturned truck in the Harz Mountains, Germany, damaged rail ways in Sutton Coldfield, Great Britain (Focus 2007) and a toppled power pylon near Magdeburg-Ottersleben, Germany (Wikipedia 2009).

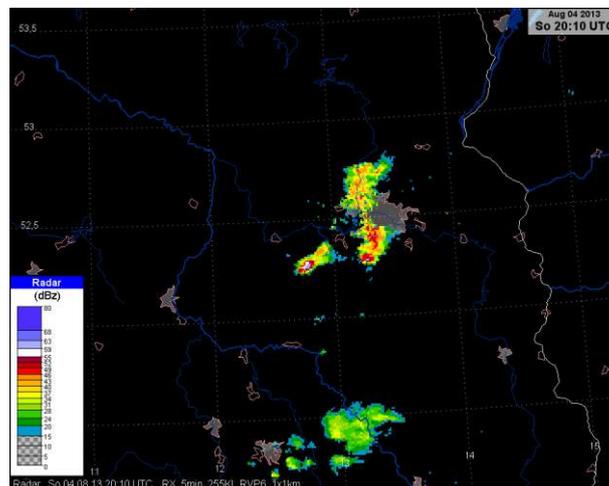
Figure 3.6. Radar image of 4 of August 2013 at 2010 UTC. A thunderstorm over Berlin. Data source: DWD.

At the back of a high pressure system, warm and humid air masses were transported into Central Europe. Temperatures in Berlin on 4 August 2013 reached almost 30 °C. During the afternoon severe thunderstorms developed in many places over Germany especially in Bavaria and Baden-Württemberg. During the night between the 4th and 5th of August, the South West of Berlin was hit by a thunderstorm. In some places, more than 13 mm of rain were recorded within 15 minutes. The radar image (Figure 3.6) shows a cluster of convective cells over Berlin.

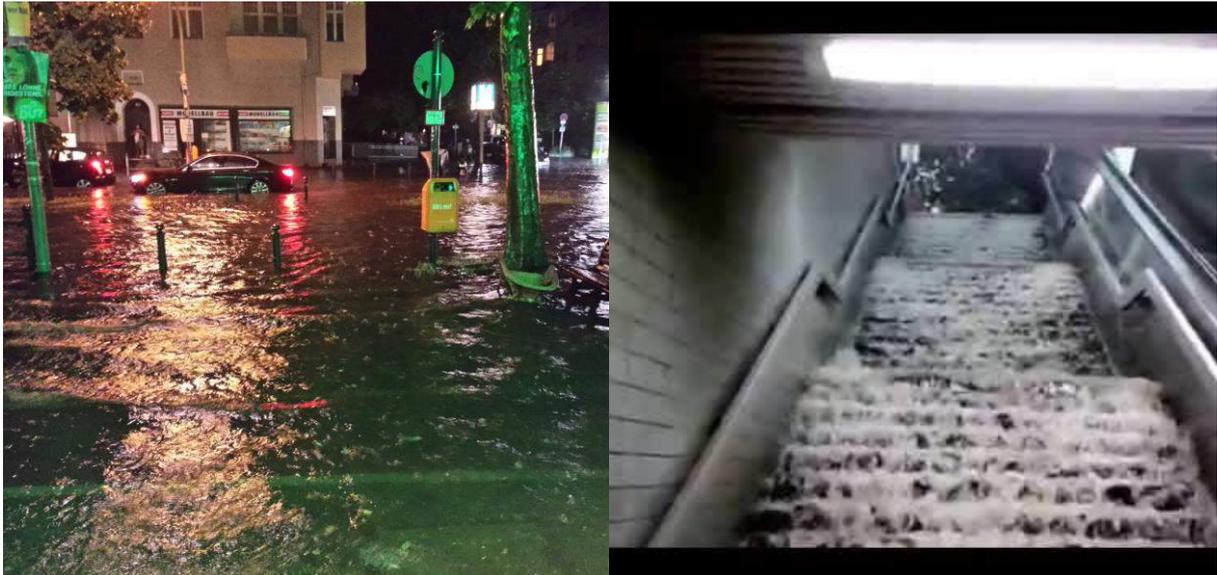
Figure 3.7. Rain has flooded streets and a subway station in the South West of Berlin. Left figure courtesy Thomas Schubert, right figure was taken from youtube video (MP 2013).

The event has flooded several streets and a subway station. The line had to be closed but could be opened again after the water masses receded. There was no long-term damage to the streets and the station.

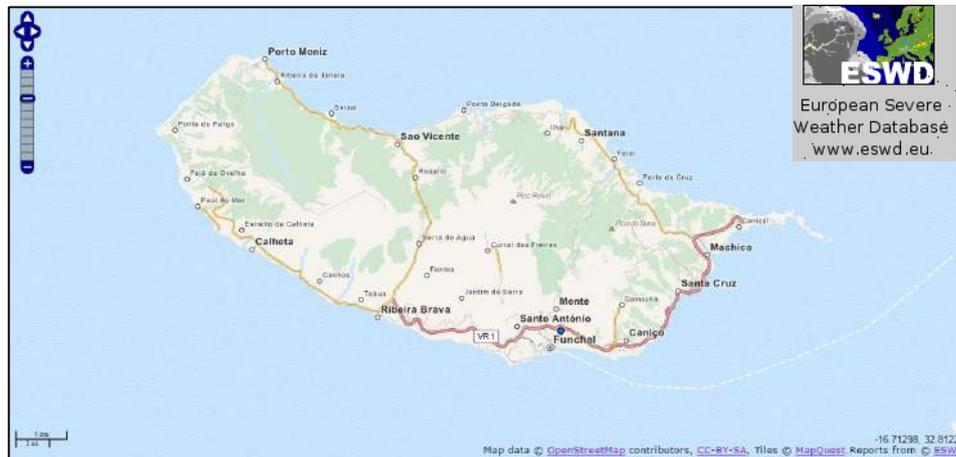
Figure 3.8. Event report (blue dot near the capital town of Funchal) from the European Severe Weather Database ESWD for 20 February 2010, and overview map of the island of Madeira

On 20 February 2010 during the morning and noon hours, severe storms devastated the communities of Tabua, Ribeira Brava, Curral Das Freiras, Santo António, São Roque, Canico, Santa Cruz, São Martinho, Monte, and as one of the worst hit towns also the capital Funchal (Figure 3.8).

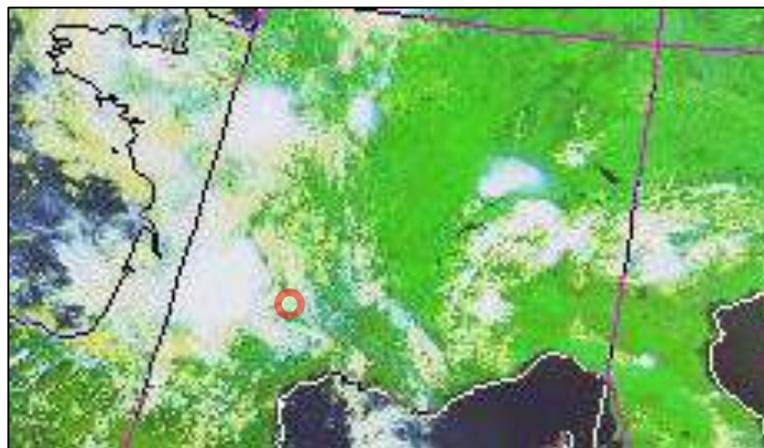
Figure 3.16. RGB composite satellite imagery of 14:47 UTC on 14 July 1987 (when storms started to form). Copyright: NERC, Dundee Satellite receiving station. Red ring: location of Grand-Bornand

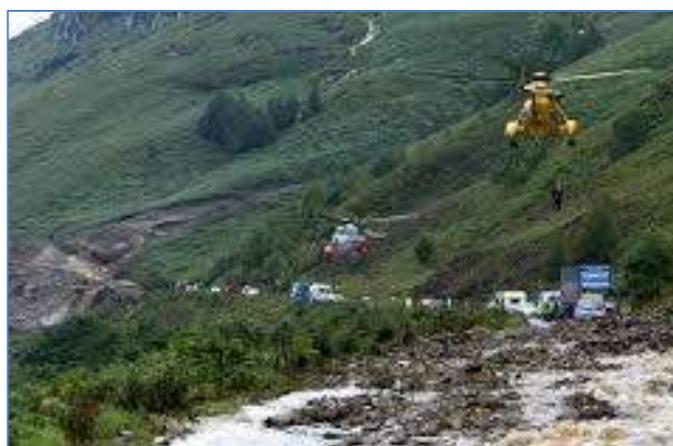
Figure 3.17. The A85 Glen Ogle. Source: www.transportscotland.gov.uk.

Whilst no major injuries occurred, the trunk road was blocked at a number of locations. The occurrence of two debris flows in close proximity on the A85 at Glen Ogle (Figure 3.17) resulted in the requirement to airlift 57 people to safety. The major impact was to traffic as a result of road closures. The A85, which carries 5,600 vehicles a day, was closed for four days, whilst the A83 and A9 which carry 5,000 and 13,500 vehicles per day respectively, were closed for two days.

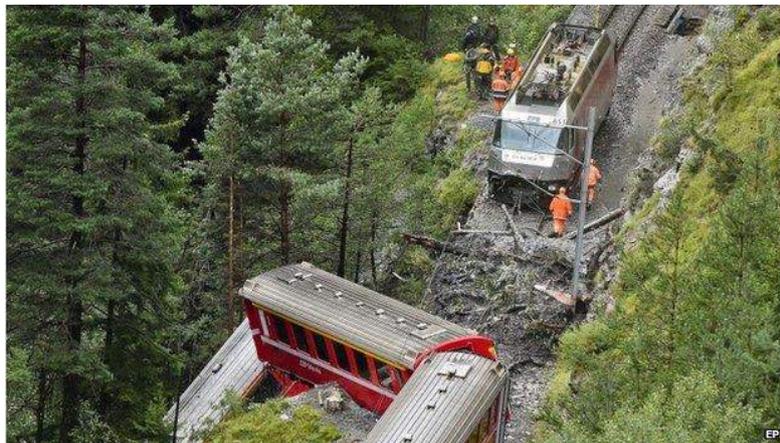
Figure 3.18. Derailment of a train near the Swiss Ski resort of St. Moritz on 13th August 2014. (image www.bbc.com)

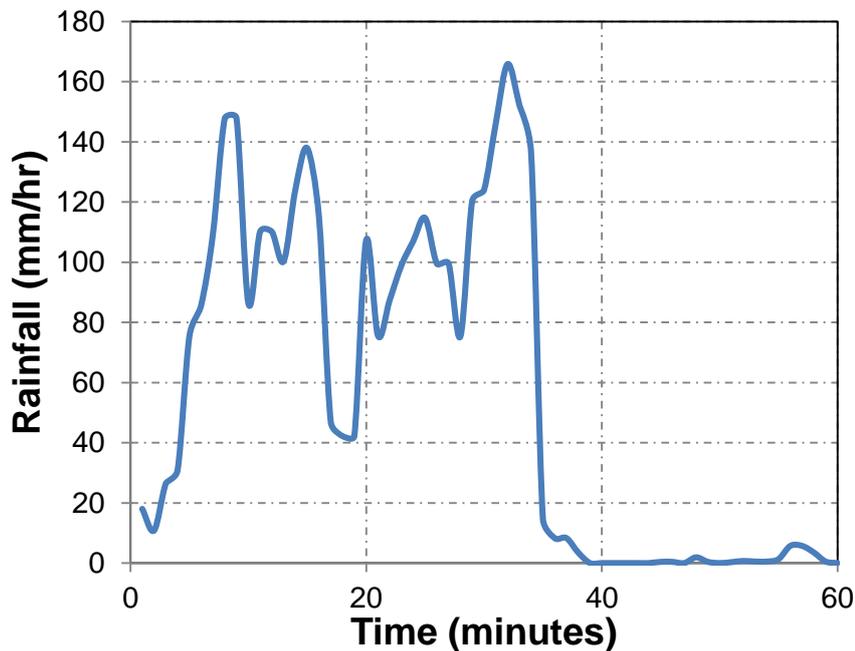
Figure 3.19. Rainfall measured at 1 minute time intervals between 18:00 and 19:00 on 11/09/2014 near the location of the rock fall

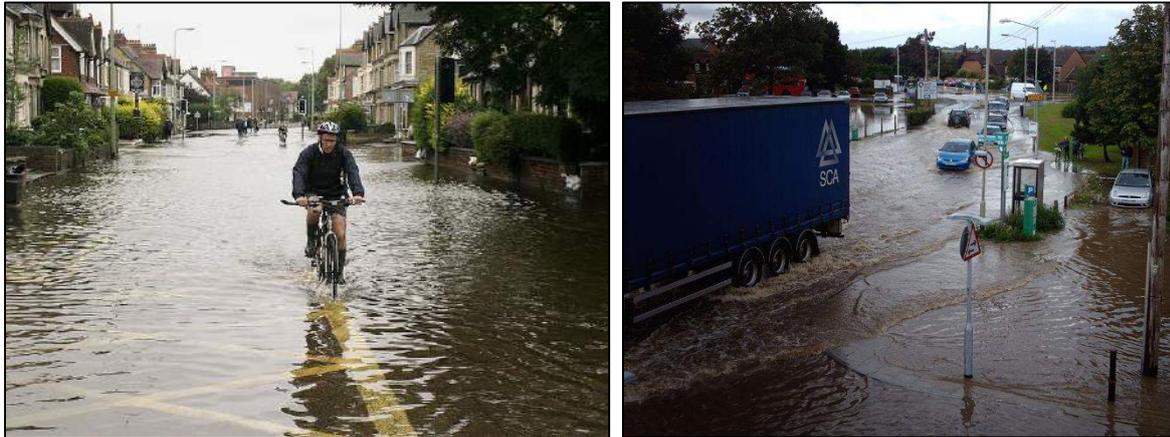
Figure 3.21. Flooded streets in Oxford (left) and Thatcham (right) (Source: Wikimedia images).

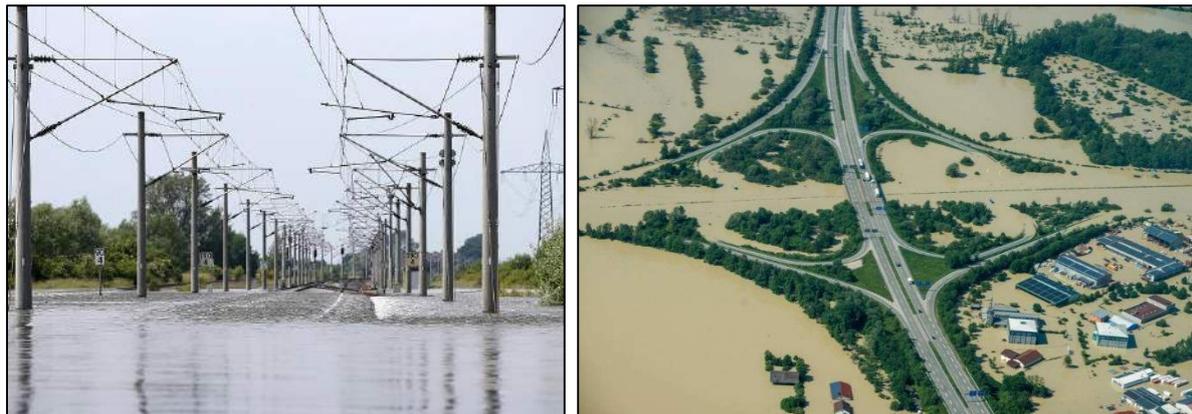
Figure 3.24. Left: Railroad in Saxony-Anhalt is flooded (Focus, 2013). Right: Motorway junction in Deggendorf (Bavaria) is flooded after dyke breach (FAZ, 2013).

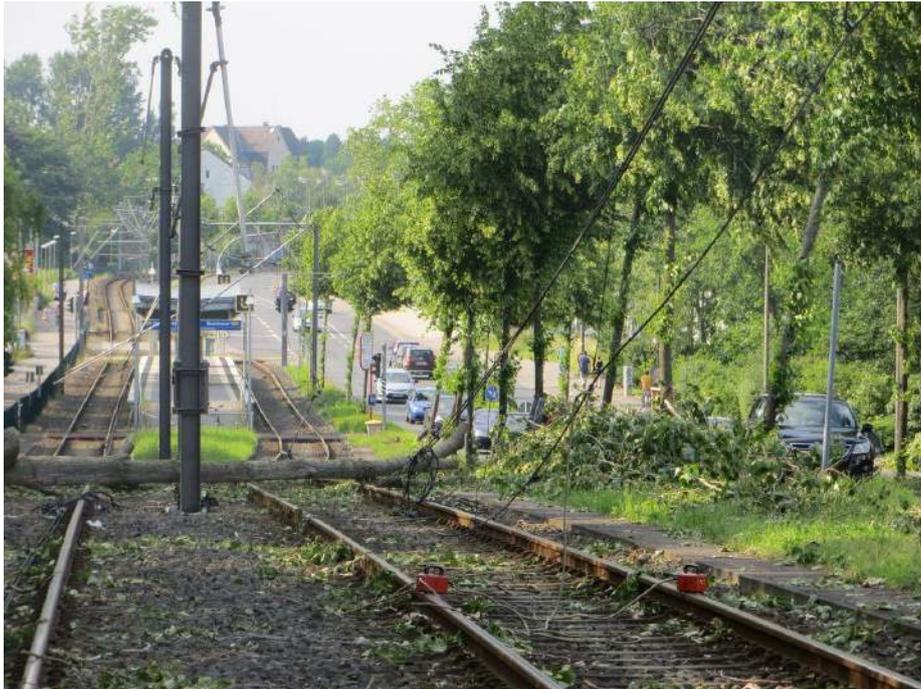
Figure 3.29. An example of a damage to the railway overhead power lines (catenary) due to the fallen tree after the convective windstorm of 9 June 2014. Photo: Rainer Klute.

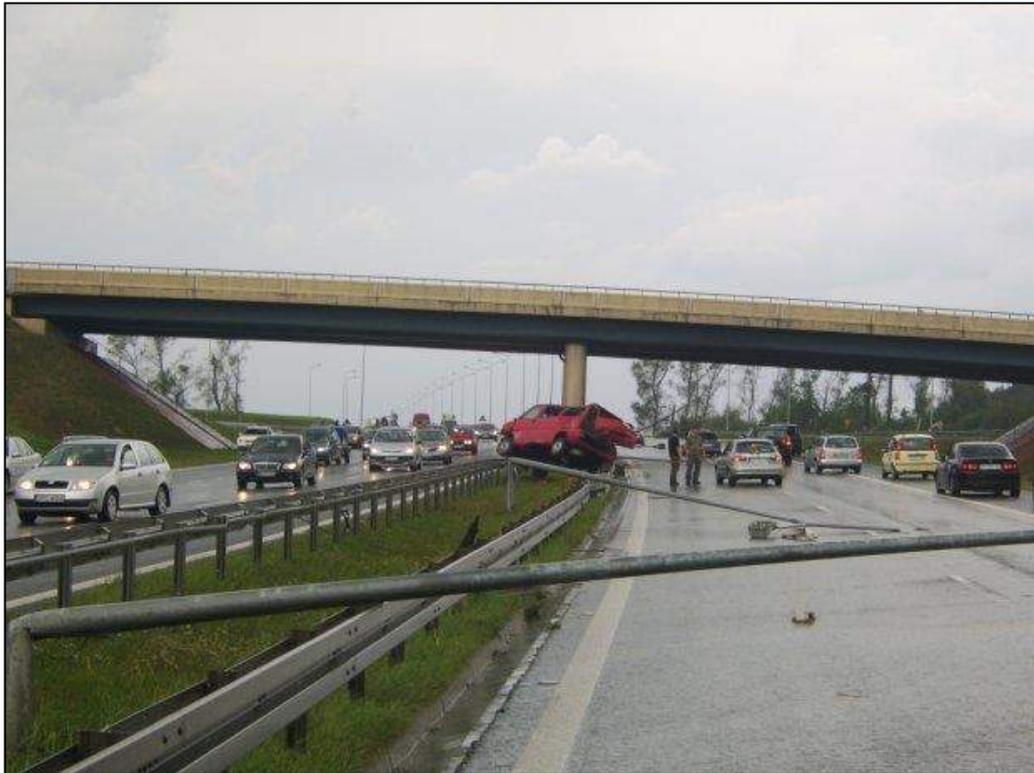
Figure 3.33. Damage to the light poles on the A4 motorway. A minivan thrown by the tornado can be seen in the back of the photo. Source: wiadomosci.gazeta.pl (2008)

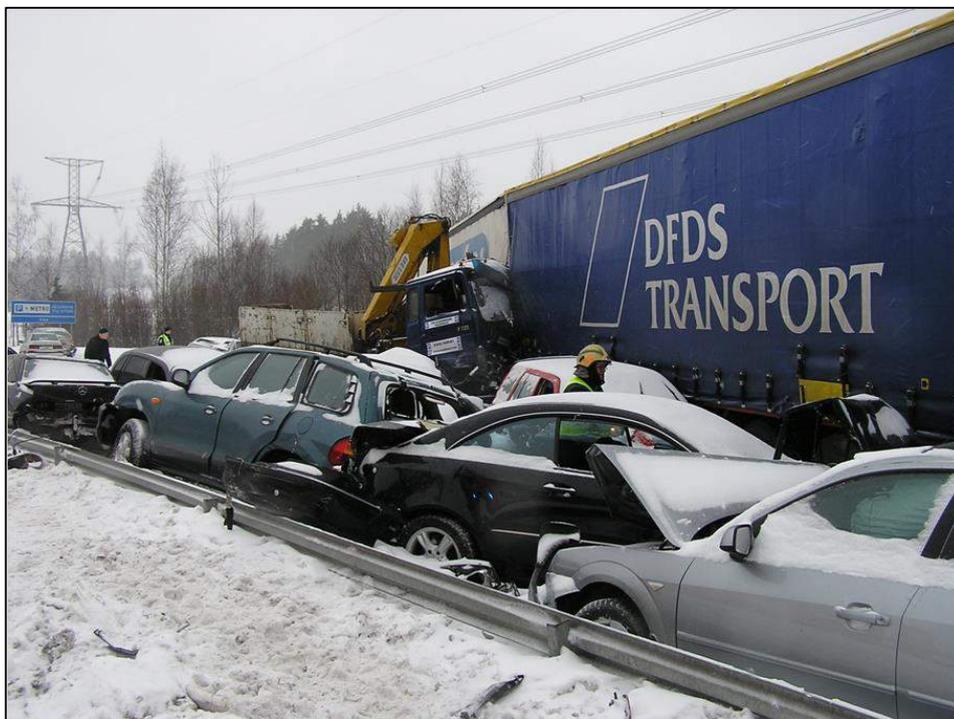
Figure 3.37. Crashed cars on 17 March 2005 near Helsinki city (photo: Board of Inquiry for Traffic Accidents).

Wintertime weather conditions challenge the fluency and safety of transportation. For example, during snowy and icy conditions, braking distances can be fourfold compared to bare road conditions (Haavasoja and Pilli-Sihvola, 2010). Whenever a reduction of both visibility and road surface grip occurs simultaneously, there is a substantial risk for severe pile-ups on crowded highways. Such events have occurred e.g. in Austria and the Czech Republic in March 2008. In Finland severe crash events happened e.g. in March 2005, in March 2011 and in February 2012. The March 2005 event is presented here (based on the studies by Juga et al., 2012). In that event, a sudden heavy snowfall during the morning rush hours of 17 March triggered severe pile-ups on four main roads in the Helsinki metropolitan area (see figures Figure 3.37 and Figure 3.38).

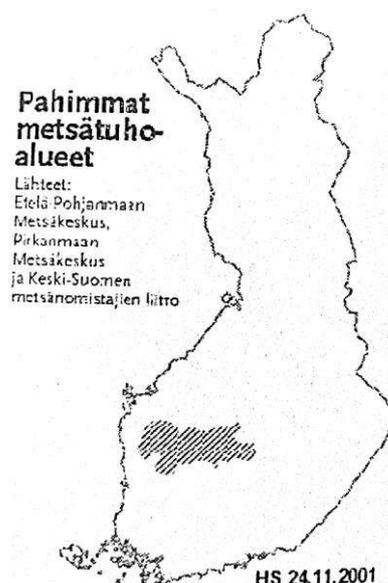
Figure 3.43. The area that suffered the most severe forest damage associated with the Pry storm (adapted from Hoppula 2005).

In November 2001 two storms, named as “Pry” and “Janika”, caused widespread damage in Finnish forests. The forest damage associated with Pry storm was not caused only because of high wind speeds but also due to a heavy wet snow loading that occurred just before the storm in central parts of Finland (Figure 3.43). It is impossible to totally distinguish between the damage caused by the heavy snow load and the subsequent storm but admittedly the combined effect of these two phenomena exacerbated the damage.

relative humidity reached 100% in atmospheric boundary layer. Atmospheric sounding profile from Jyväskylä airport, situated in the eastern part of the hatched area in Figure 3.43, on the late evening of October 29 is shown in Figure 3.45. Moisture was condensed into freezing fog and stratus clouds below the shallow inversion in the boundary layer. Weather conditions were thus favourable for riming and Hoppula (2005) estimated that, for instance in Seinäjoki about 150 km west-north-westwards from Jyväskylä, approximately 3 mm of rime was accumulated during the night.

The damage related to the Pory storm was largely caused by heavy snow loads but it is impossible to totally distinguish between snow and wind induced damages. The most severe damages were restricted to the areas which experienced first the heavy snow loading although the storm was more widespread (Figure 3.43, Figure 3.44). In many sources the damages are also combined with those caused by the Janika storm two weeks later largely on the same areas and it was more devastating storm than Pory. These two storms cut down 7.3 million cubic meters of wood in Finland (Metsätuhotyöryhmä 2003) and 90,000 trunks were fallen over power transmission lines (Ihalainen and Ahola 2003). Repair costs for power companies totalled approximately 11 M€ and forest damage caused equal loss for forest owners (Ihalainen and Ahola 2003); however, the total damage caused to electric supply companies was mainly due to the Janika storm.

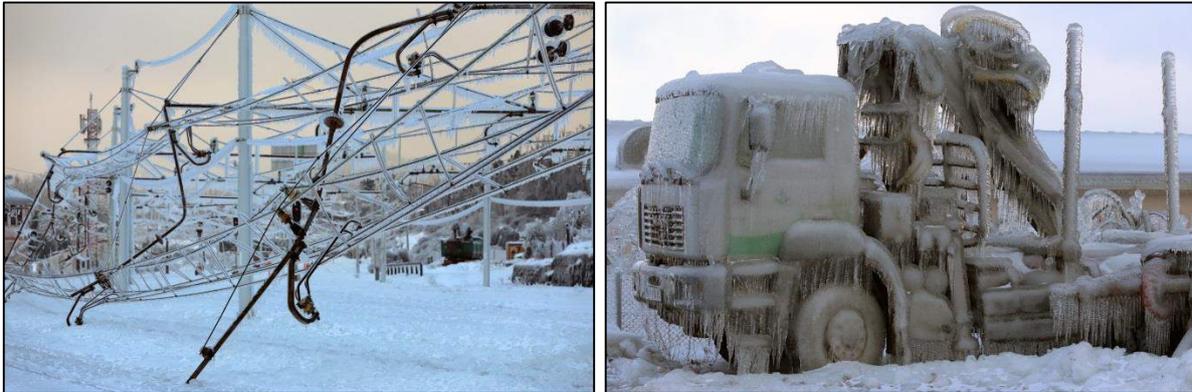
Figure 3.52. Ice-damaged rail infrastructure at the Postojna railway station; ice covered truck in Postojna (photos by D. Rozman).

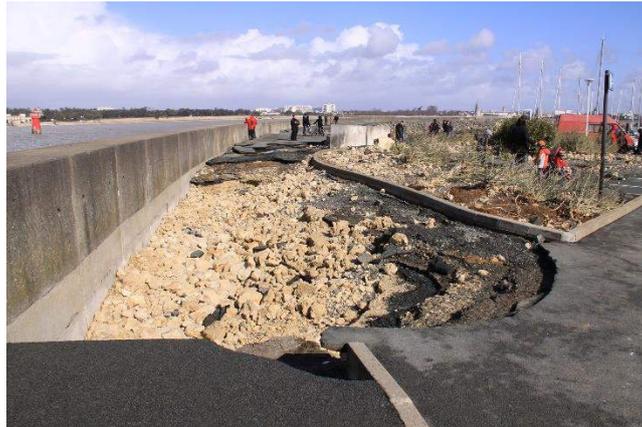
Figure 3.58. Damaged parking in La Rochelle (source: Wikipedia).

Many damages to roads were recorded, since many communal and even departmental roads are located atop of dunes and embankments. Those were eroded during the storm, destroying the roads (Figure 3.58). That includes several locations far from the main flooded zone, such as Moutiers-en-Retz, more than 100 km north, where dune erosion undercut a departmental road. Many roads were flooded cutting off affected villages. Several bridges had to be closed during the storm, restricting access to Ré and Oléron islands. All over the country, traffic disruptions occurred because of falling trees blocking the roads (Bersani et al. 2010, Pedreros et al. 2010, Maurer et al. 2012).

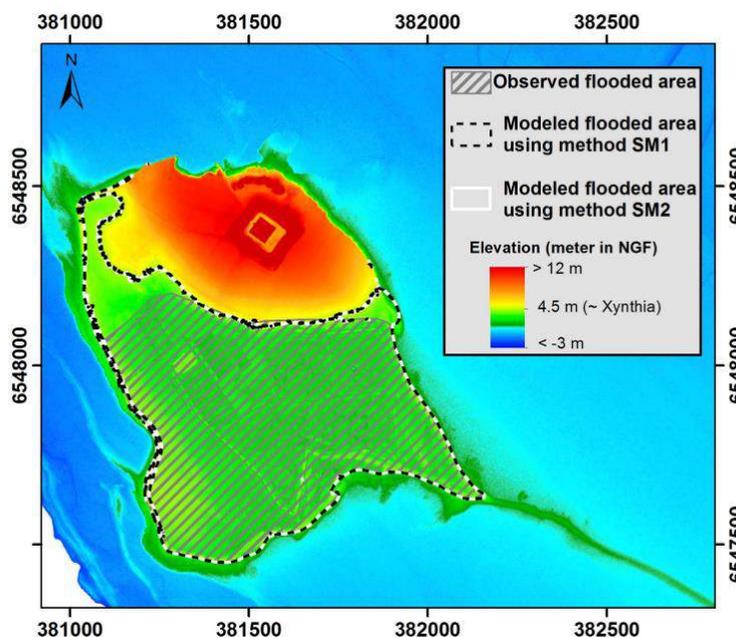
Figure 5.1. Example of a 'bathtub fill' approach (at different assumed water levels, SM1 and SM2) used in a case study in France (Breilh et al. 2013).

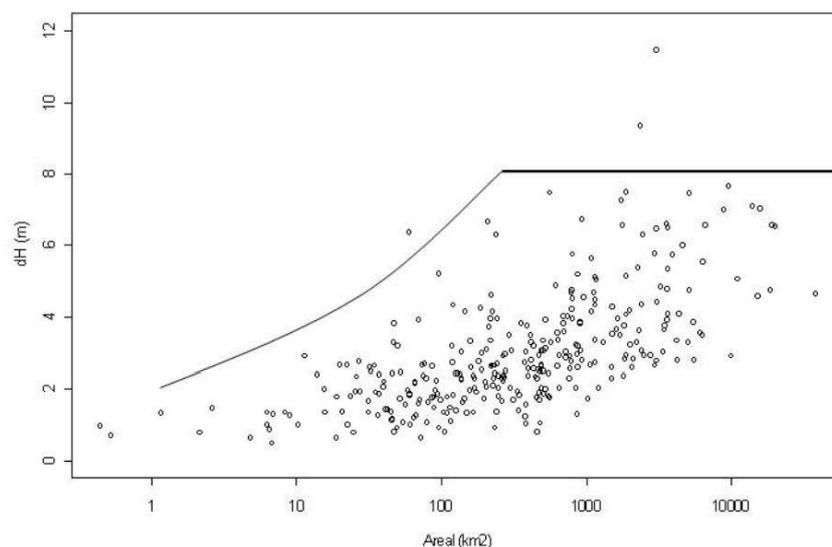
Figure 5.2. Relation between catchment area and water levels in Norway and the function (solid line) used for preliminary flood risk assessment (NVE 2011).

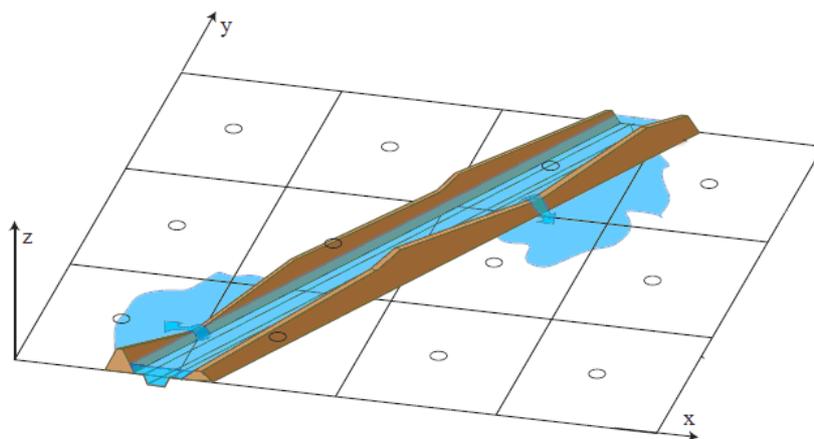
Figure 5.3. An example of a hybrid 1D/2D model (KZGW 2010).

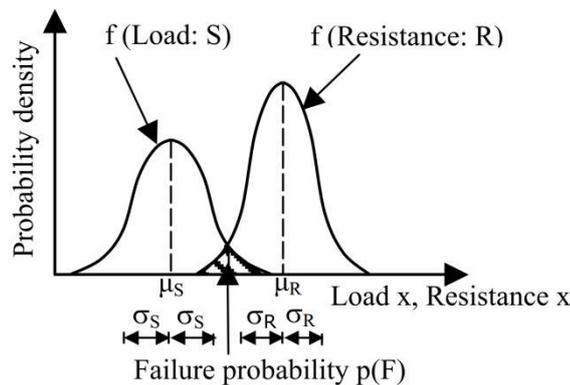
Figure 5.4. Failure probability as an outcome of load and resistance probability (Möllmann and Vermeer 2007)

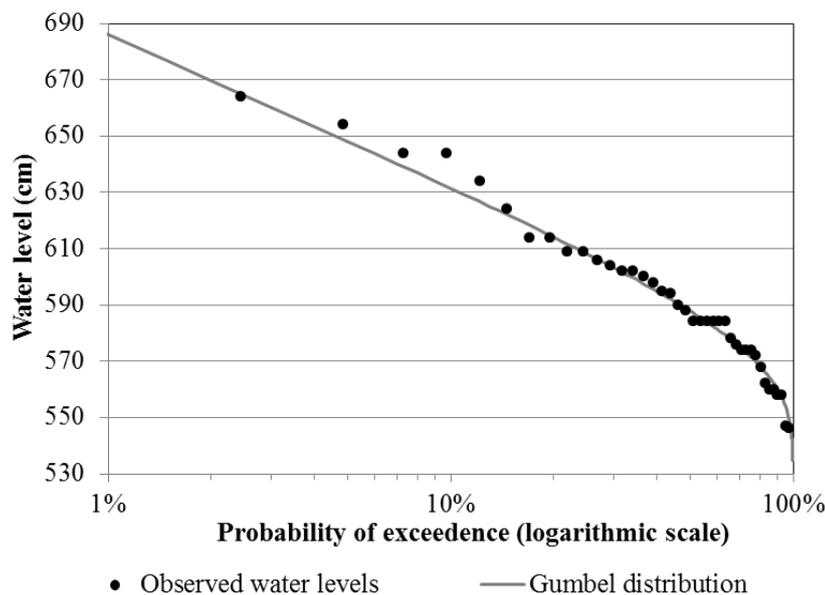
Figure 5.5. Empirical and theoretical (Gumbel) distribution of annual maximum water levels in Kołobrzeg (1901–1940). Adapted from Paprotny (2014).

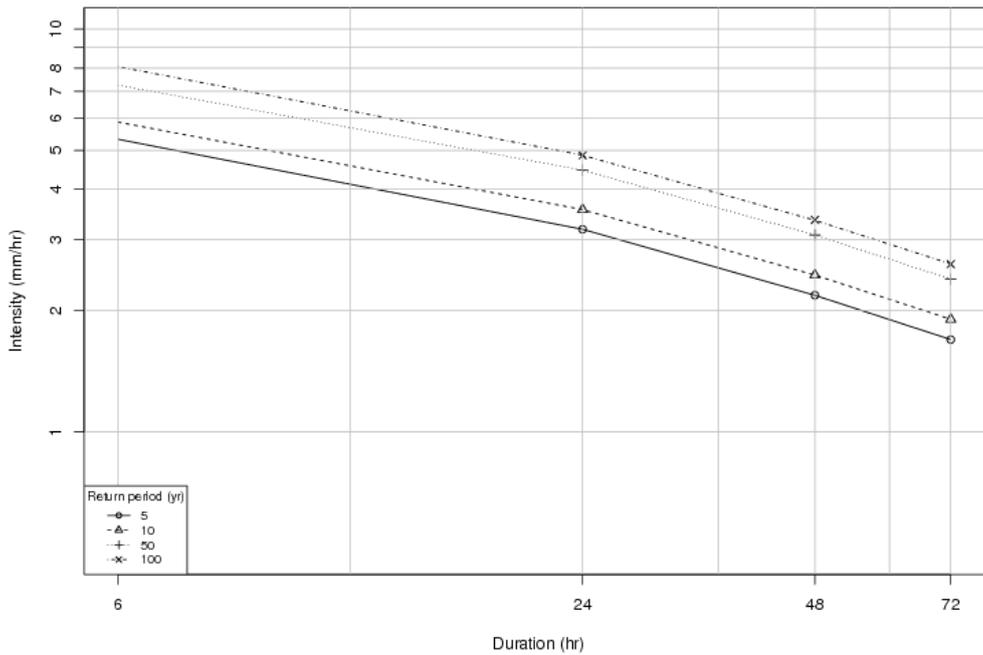
Figure 5.10. Intensity duration frequency curve for a grid point over Slovenia. Based on the E-OBS data set.
