Heavy rainfall event in Žilina region, Slovakia, in 2014 and its impacts on infrastructure and society

RAIN Workshop
*Critical Infrastructure
Safety in the Context
of Climate Change*

4th April 2016

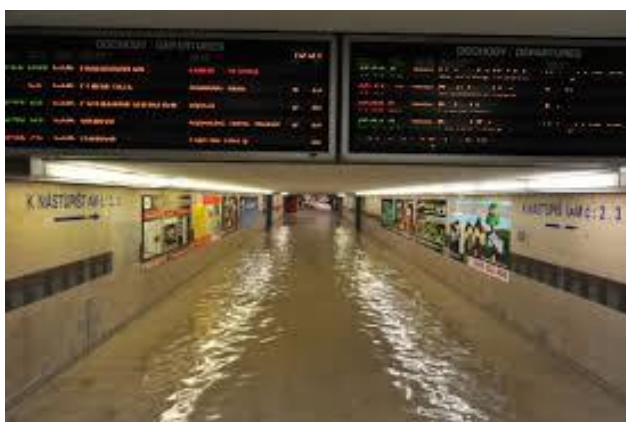
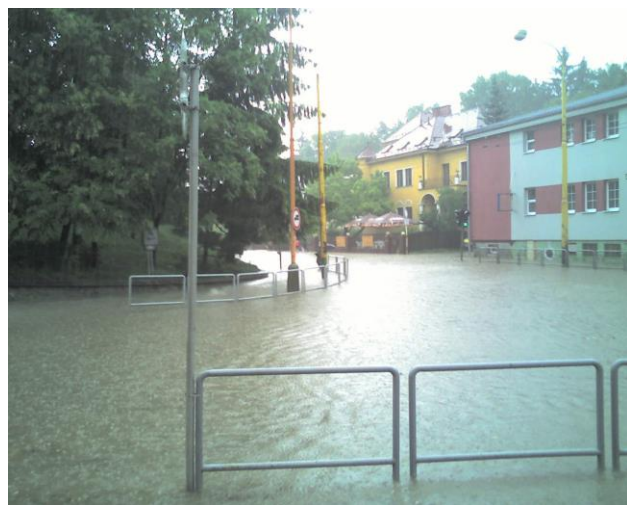
Žilina

Heavy rainfall – flash flood

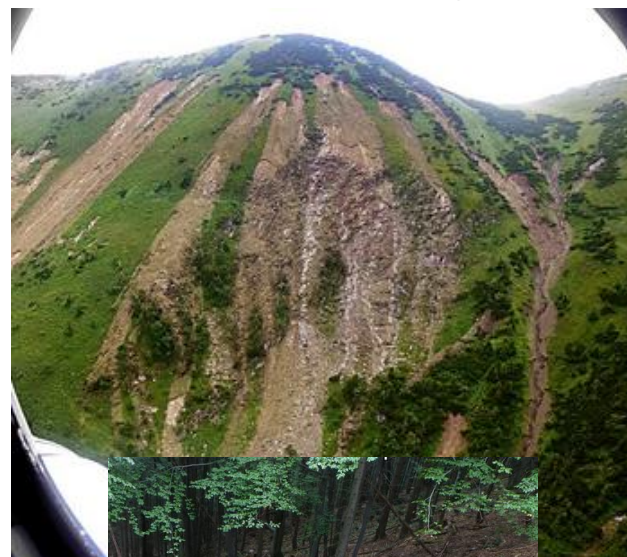
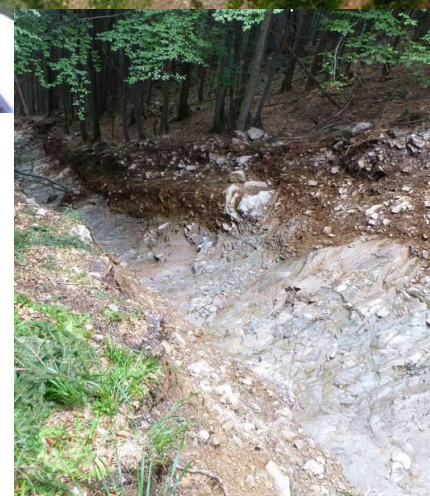
Vrátna Valley

Heavy rainfall – landslides

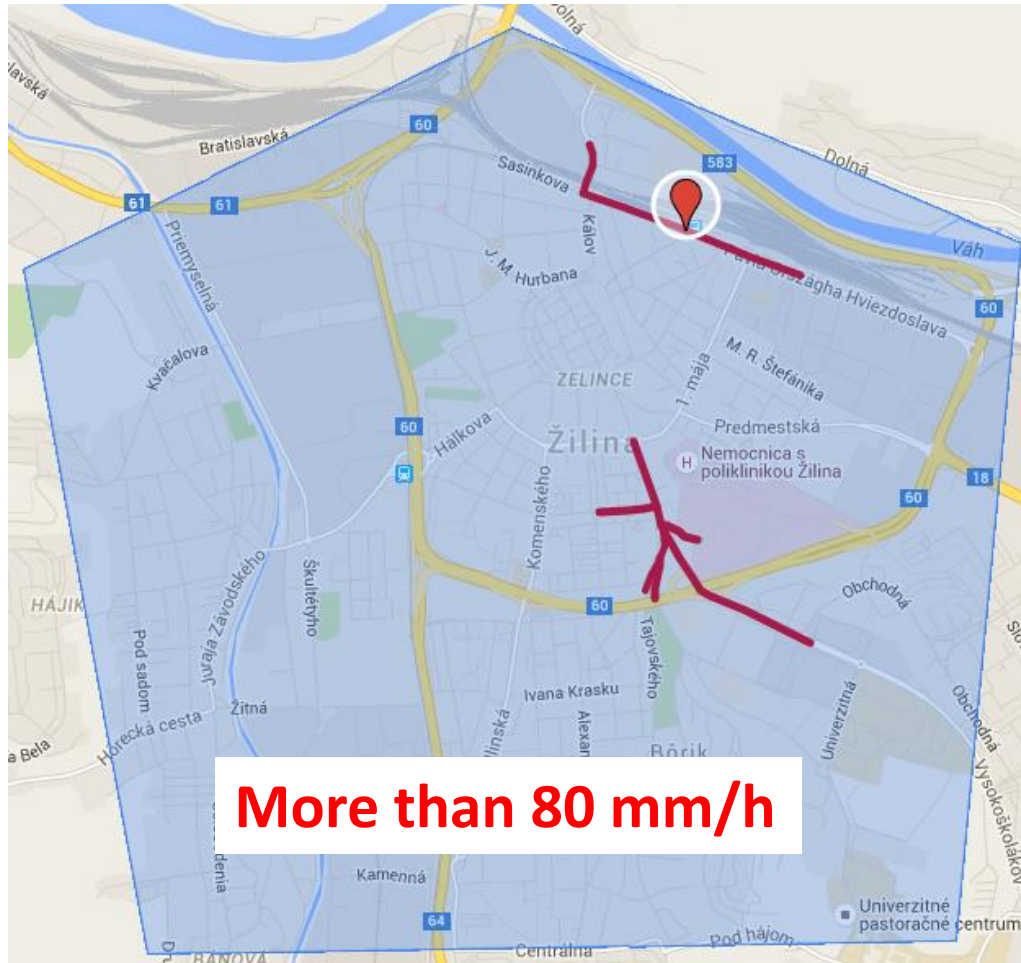
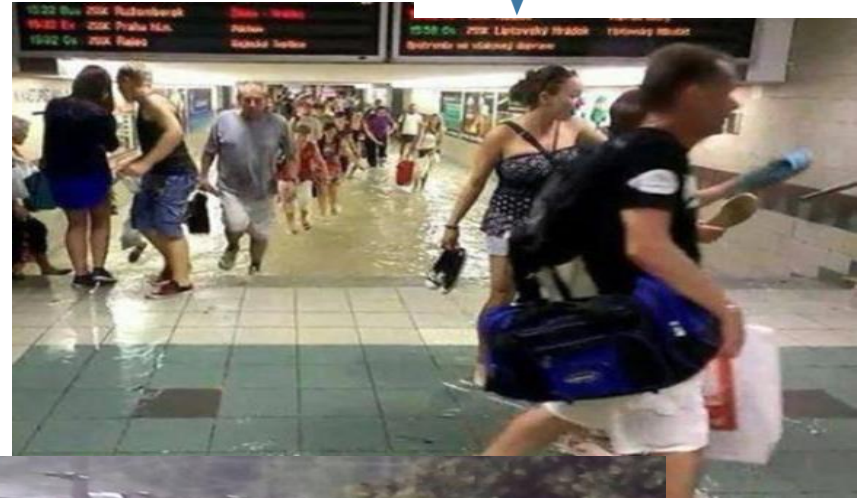
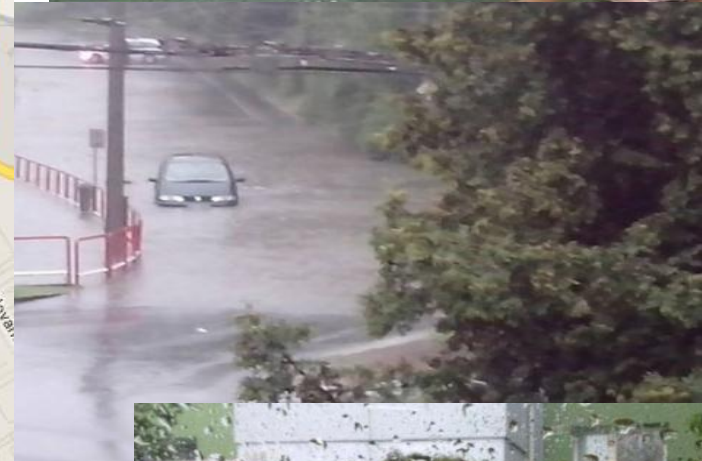
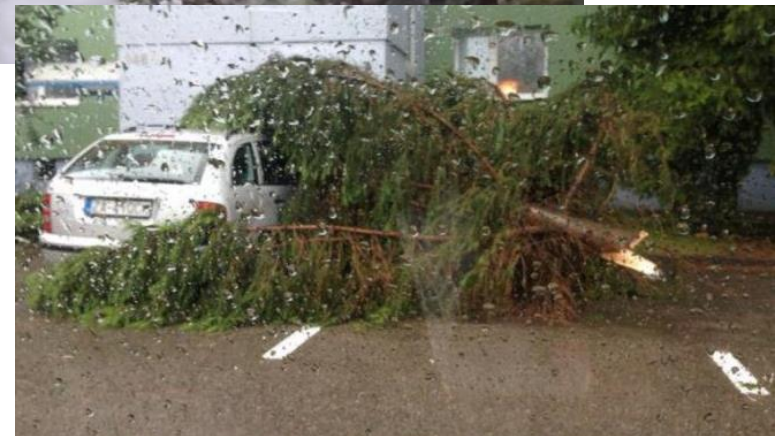
Žilina City

Heavy rainfall – flash flood

More than 80 mm/h

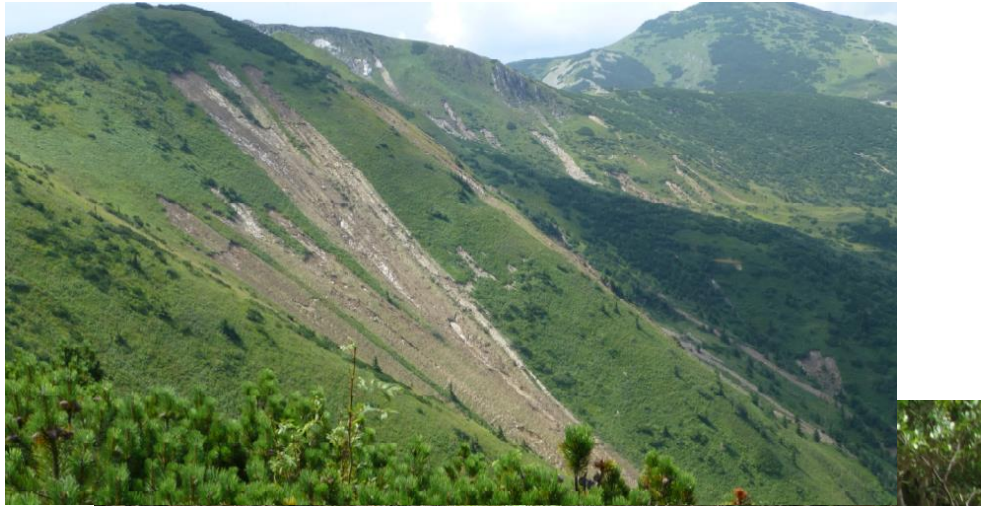
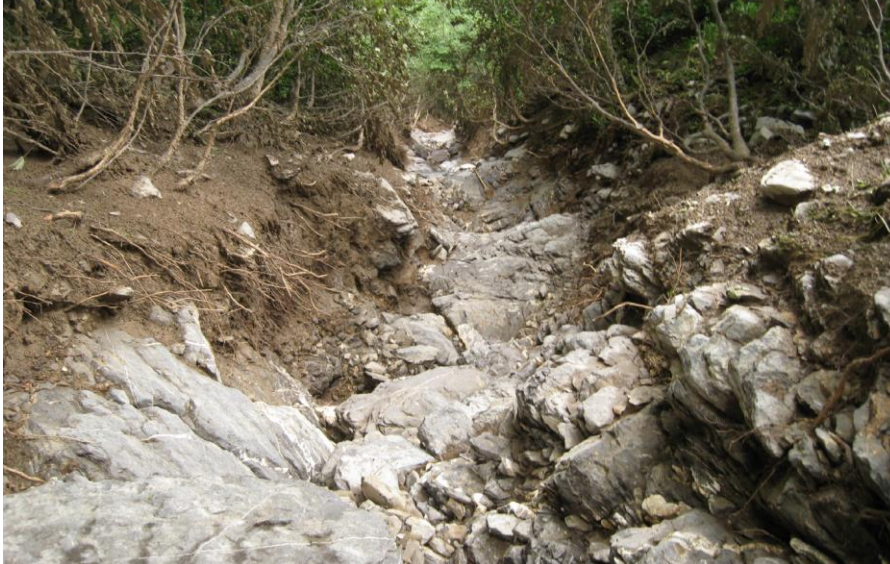
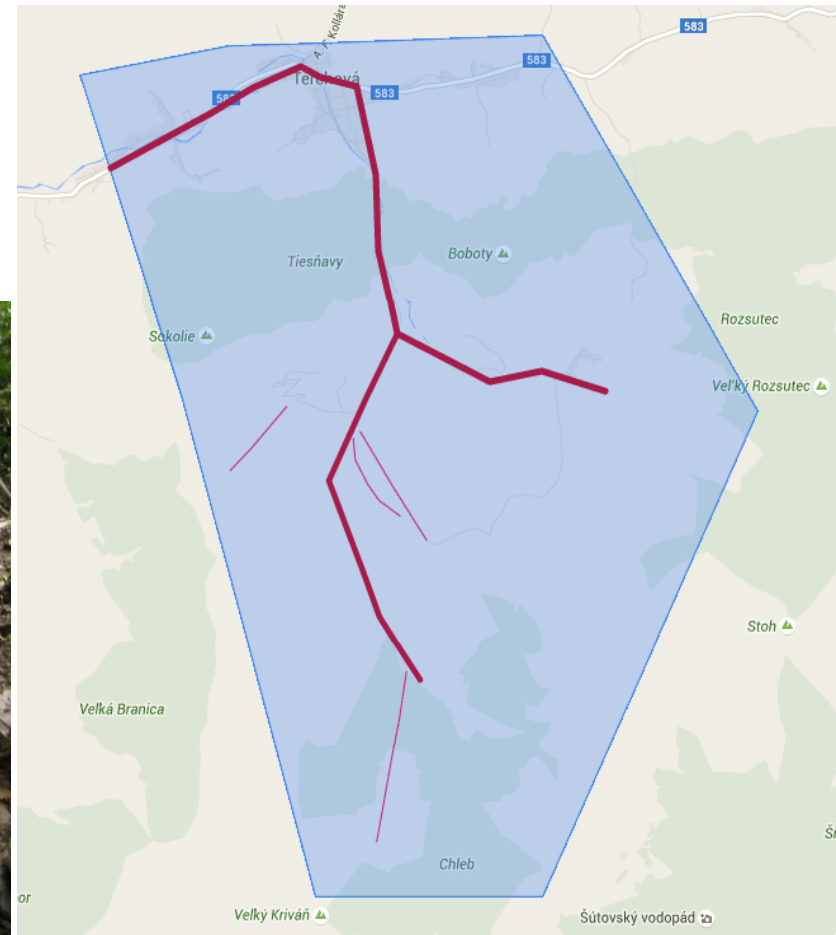
Vrátna Valley – Terchová

Landslides/Rock-clay flood flow

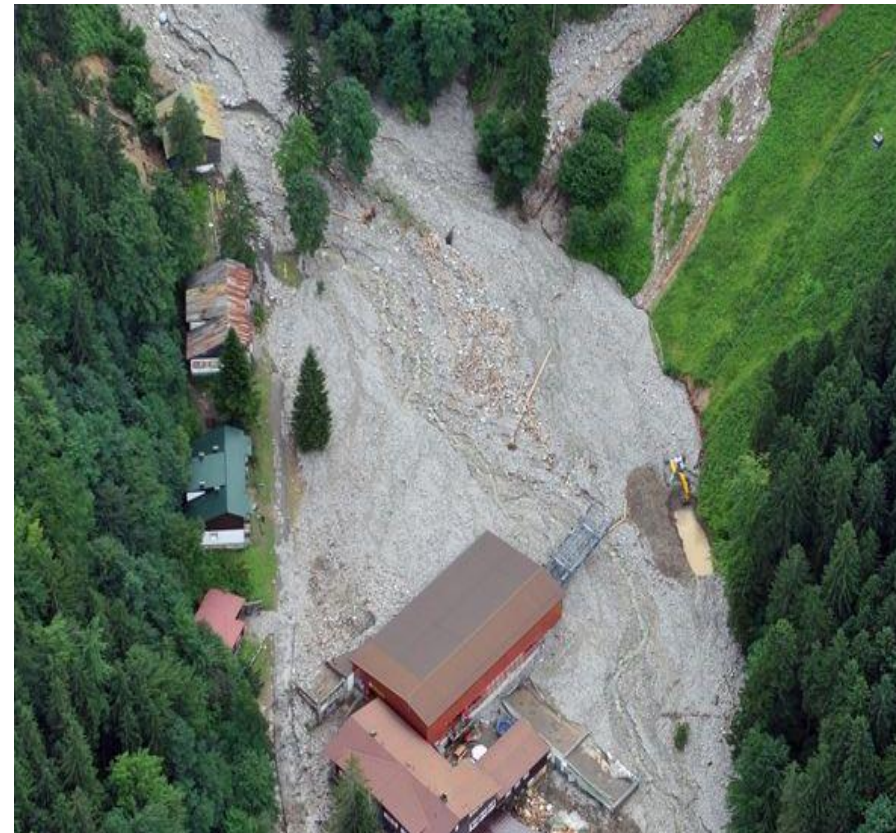
- The worst situation was in the glacier peaks Chleb, Steny a Hromové.
- At a height of 1500-1600 m.a.s.l. was floated **moraine sediments and stone rubble**, which, together with the vegetation formed flows with a thickness of 1-2 m.
- The numerous "plates" of rock-clay material was tear off (each part about 100m²) – with **landslide/avalanche** speed from 10 to 20 m/sec.
- In one point these flows began **blur together**.
- Main flow continued to narrow stream valley, gathering additional bottom sediment, stones, earth, and trees.
- Flow reach an adjacent **infrastructure, buildings and villages** with destructive impacts.

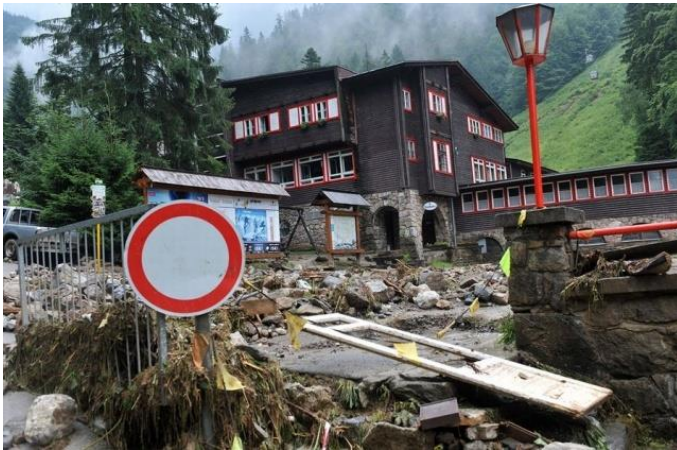
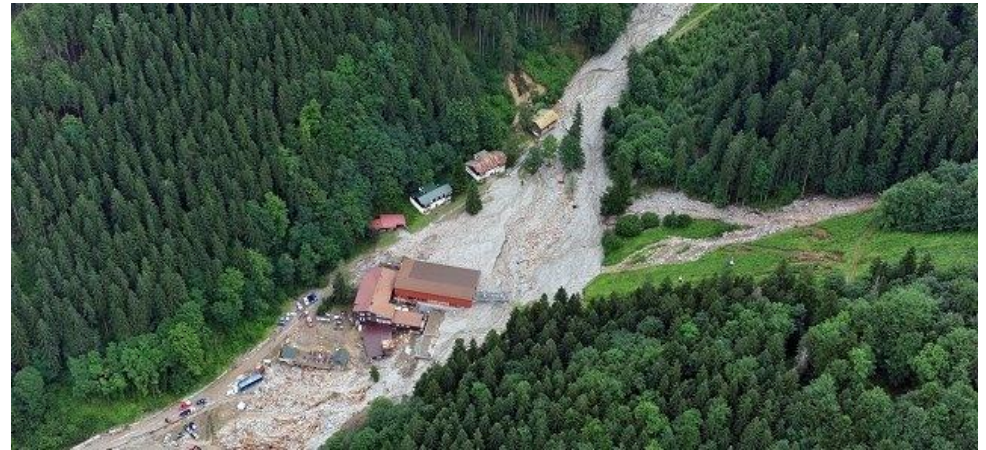
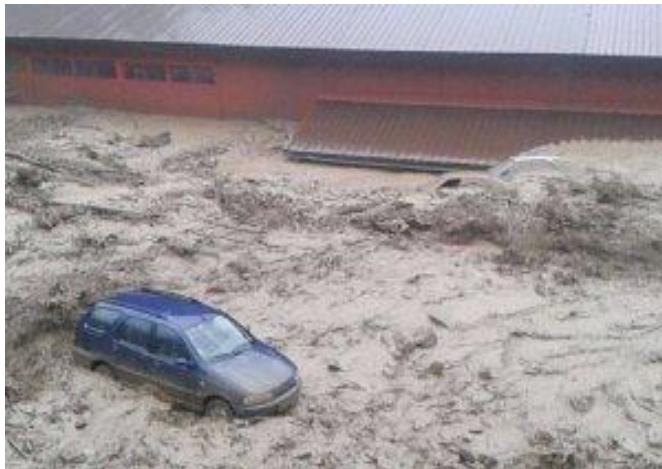
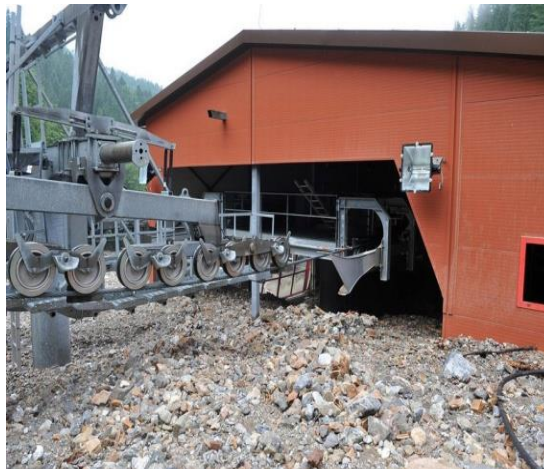
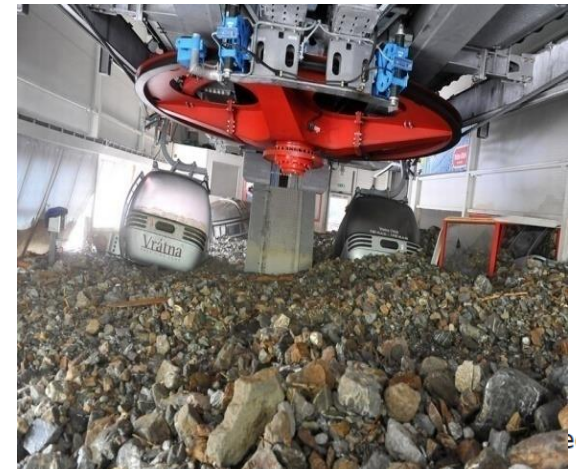
Tourism Impacts

- Tourist resort (summer and winter),
- cableway.

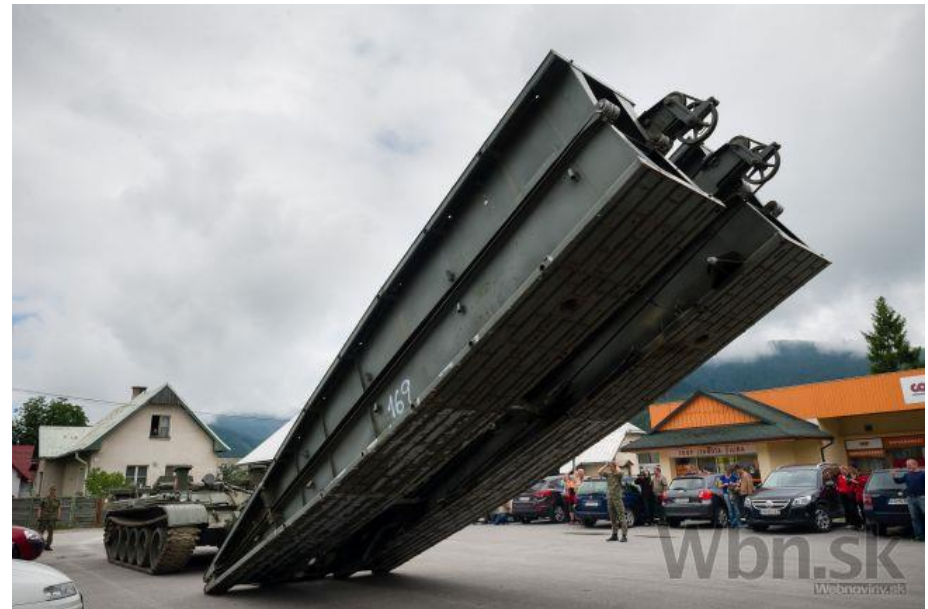
The pontoon bridge setting by armed forces of the Slovak Republic

- Accessing cut ends of the villages
- Setting of 2 provisional bridges
(national government in coordination with the armed forces of the Slovak Republic)
- Construction and reconstruction of 6 footbridges
- Protection of drinking water
