<b>Deliverable Reference</b>	<b>D 7.1</b>
<b>Deliverable Name</b>	<b>Analysis of practical remediation strategies for discrete infrastructure systems</b>
<b>Contributing Partners</b>	<b>GDGEO</b>
<b>Date of Submission</b>	<b>August 2015</b>

RAIN – Risk Analysis of Infrastructure Networks in Response to Extreme Weather

# Analysis of Practical Remediation Strategies for discrete Infrastructure systems

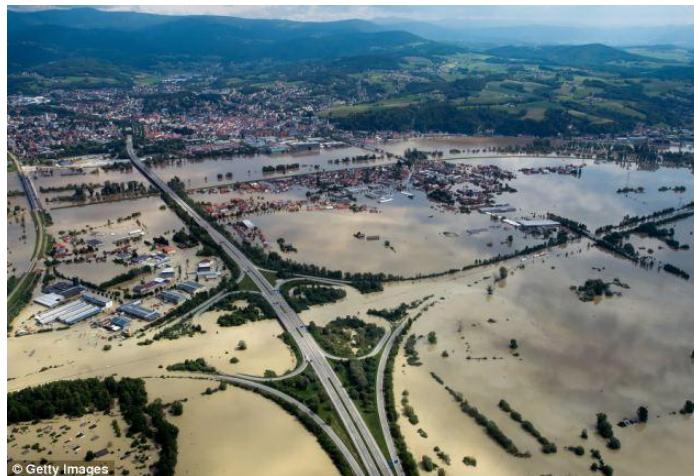
**Figure 1 Flooding of a motorway junction in June 2013 at Deggendorf, Germany<sup>1</sup>**

The Danube is the EU's longest river and flows through a number of Central and Eastern Europe countries, including Germany, Austria, Hungary, Croatia, Romania, Bulgaria, Slovakia, Ukraine, Serbia and Moldova. The incidence of flooding on the river appears to be increasing, with major floods reported in 2002, 2005, 2006, 2009, 2010, 2013 and 2014. The 2013 flood was particularly severe and caused major disruption and multiple closures of sections of the rail and road networks across the region,

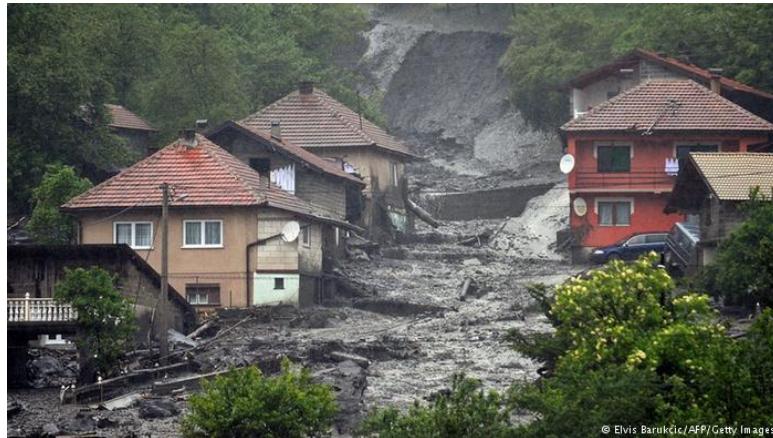
**Figure 2 Landslide triggered by a major flood event 2014, Bosnia<sup>2</sup>**

The increased intense and more regular return period of heavy rainfall events across Europe is leading to an increase in rainfall induced slope failures which can cause severe damage to transport infrastructure,

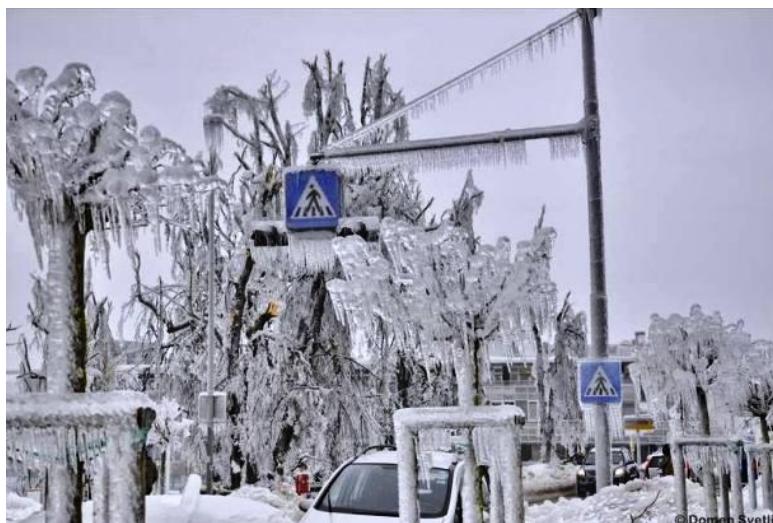
**Figure 3 Freezing Rain in Slovenia (town of Postojna), November 2013<sup>3</sup>**

In early February 2014, Slovenia and particularly the city of Ljubljana were affected by a particularly harsh fall of snow and freezing rain, Figure 3. The storm had a severe effect on the power grid with some regions suffering complete power outages for two days and loss of mobile telecommunications networks.

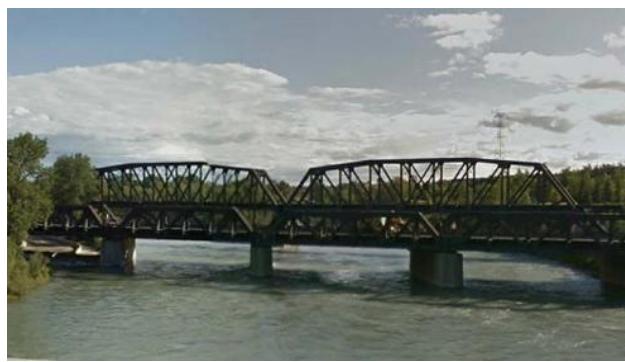
Figure 4 The Bonnybrook Bridge before the flood <sup>4</sup>

The Bonnybrook Bridge is a 465-foot-long, 5-span bridge, located in southeast Calgary which spans the Bow River, Figure 4. It is a key element of Canadian Pacific Railway (CP)'s east–west rail network. The original bridge, built in 1897, was a single-track structure that consisted of two 61 m long through-truss spans supported on 2 stone masonry abutments and a stonemasonry pier. The bridge was expanded to accommodate an additional two tracks in 1912, and another bridge for a fourth track was added in 1969.

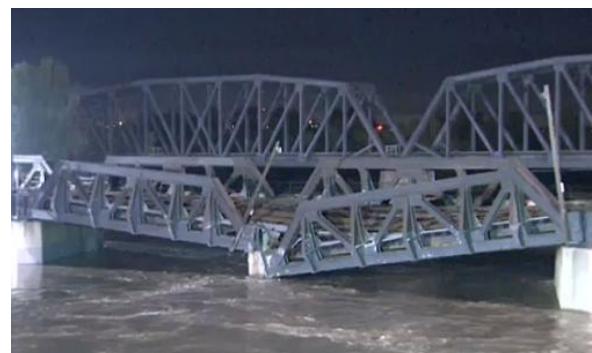
Figure 5 The Bonnybrook Bridge after the flood <sup>5</sup>

On the 27<sup>th</sup> June 2013, a section of the bridge collapsed, Figure 4, as a result of extreme flooding, during which the flood waters had attacked the shale bedrock/clay pier foundation of the original bridge, eroding and undermining it, resulting in failure of one of the original piers. The flooding had resulted from record rainfalls of 150mm that occurred in a 48 hour period, upstream of the Bow River on the 20<sup>th</sup> June 2013. As a result, on the 21<sup>st</sup> June the Bow river reached a peak flow 1740m<sup>3</sup>/sec and between the 21<sup>st</sup> and 24<sup>th</sup> June the water level was only 20 cm below the underside of the bridge deck, Figure 5. At the time of collapse, a train carrying petroleum tankers was traversing the bridge. Fortunately, emergency services acted swiftly to prevent loss of any of the contents of the train's cargo.

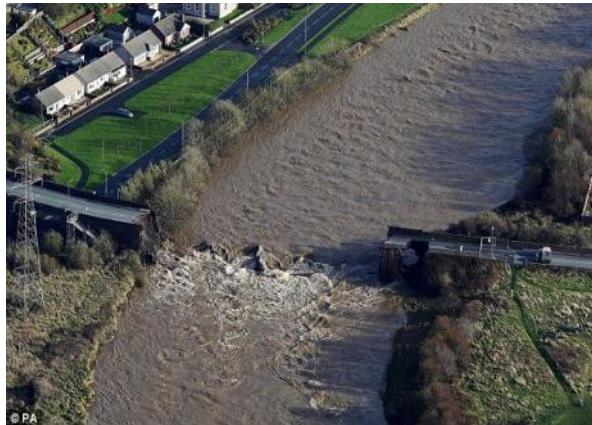
**Figure 6. Northside Bridge, Workington<sup>6</sup>**

flooded much of central Cockermouth. The effect of this water rushing towards Workington destroyed the Northside road bridge, Figure 6 , and the Calva road bridge, Figure 7, which was closed after the main deck was displaced downwards by approximately 30cm and a large crack appeared in the central arch.

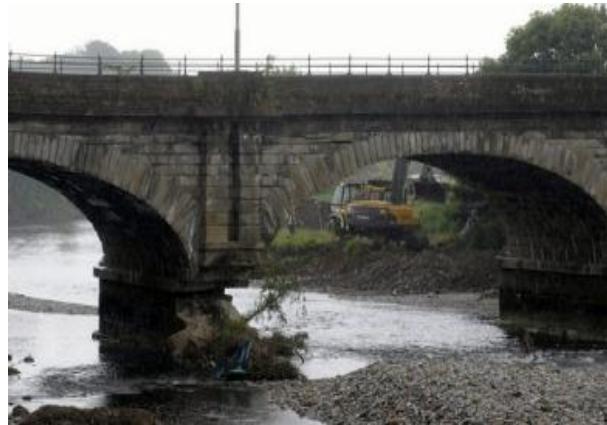
**Figure 7 Calva Bridge, Workington<sup>7</sup>**

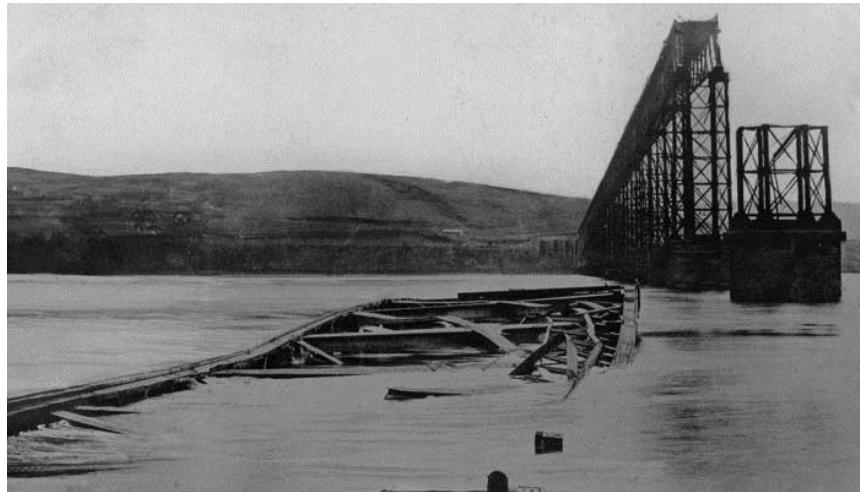
**Figure 8 Fallen girders, Tay Bridge<sup>8</sup>**

The Tay Bridge, with a span of 3.5 km, carries the main-line railway across the Firth of Tay in Scotland. The present structure is the second one on the site. The first bridge, a single-track lattice design, opened in 1878 and was noted for its light weight and low cost. Its sudden collapse in high winds on 28<sup>th</sup> December 1879 was one of the great engineering disasters of history (Scheer 2010). At the time of the collapse, a gale estimated at 80–117 km/hr was blowing down the Tay estuary at right angles to the bridge. The collapse of the bridge, Figure 8, is still the most notorious bridge disaster of the British Isles (Scheer 2010-). The stumps of the original bridge piers are still visible above the surface of the Tay even at high tide.

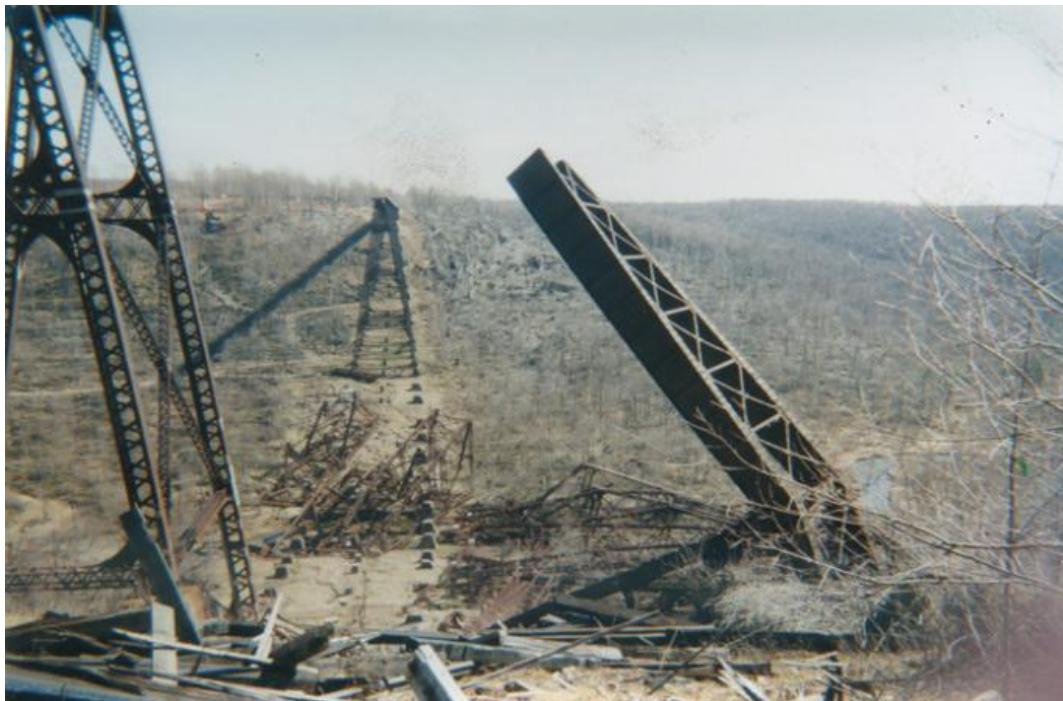
Figure 9 Kinzua Bridge, April 2004<sup>9</sup>

The Kinzua Bridge was a railroad bridge, 92 m high and 625 m long and spanned Kinzua Creek in McKean County in the U.S. state of Pennsylvania. The bridge was originally built from iron in 1882 and held the record as the tallest railroad bridge in the world for two years. In 1900, the bridge was dismantled and simultaneously rebuilt out of steel to allow it to accommodate heavier trains. Restoration of the bridge began in 2002, but before it was finished, on July 21, 2003, a tornado struck the Kinzua Bridge, snapping and uprooting nearby trees, as well as causing eleven of the twenty bridge towers to collapse, Figure 9. The failures were due to the failure of the bolts holding the bases of the towers to the concrete anchor blocks embedded into the ground. An investigation determined that the tornado had a wind speed of at least 151 km/h, which applied an estimated 800 kN of lateral force against the bridge (Fleming, 2003). The investigation also hypothesized that the whole structure oscillated laterally four to five times before fatigue started to cause the base bolts to fail. The towers fell intact in sections and suffered damage upon impact with the ground. The state decided not to rebuild the Kinzua Bridge, which would have cost an estimated \$45 million.

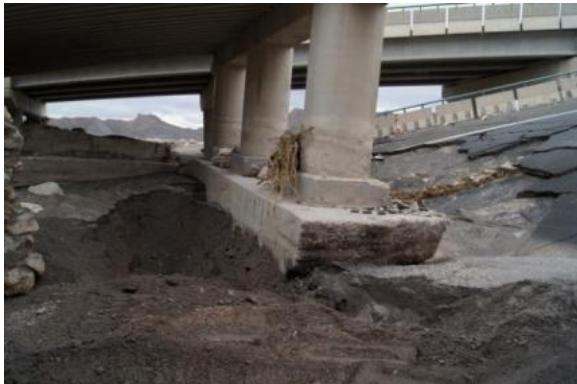
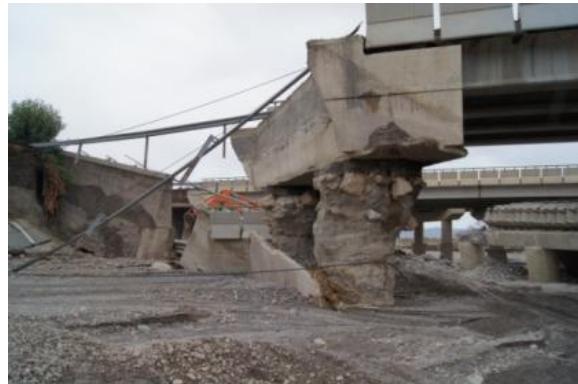
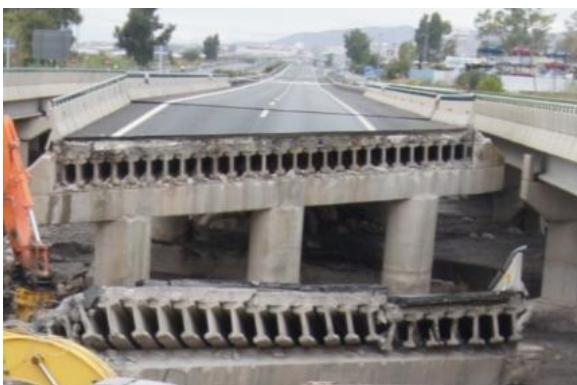
Figure 10 Bridge on the Almeira Bound Carriageway <sup>10</sup>

(a) Pier nº 6 collapsed

(b) Abutment nº 2

(c) General views of Collapsed Structure

The worst affected bridge was on the Almería-bound main carriageway. The flooding resulted in the scour and collapse of the piers, Figure 10a, and damage to one of the abutments, See Figure 10b. This in turn affected the embankments of access E-2 of the main carriageway and the service road of the carriageway. The collapse of the abutment and piers triggered the collapse of some of the spans, Figure 10c. The flood also affected the backfill of some abutments.

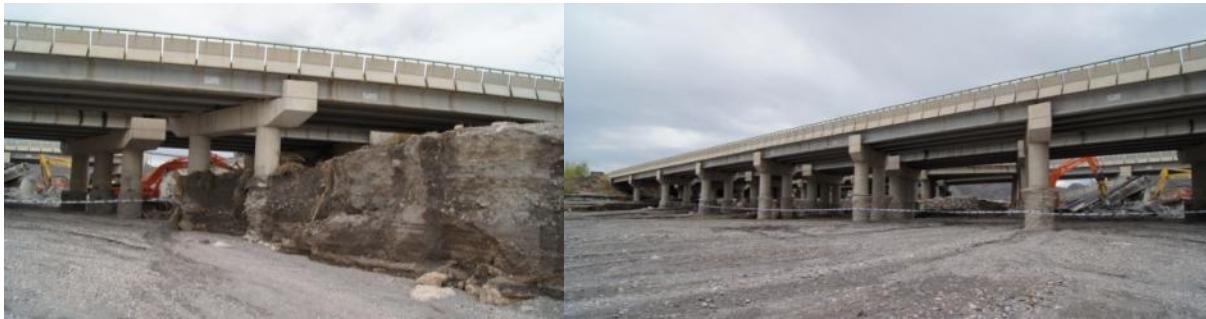
**Figure 11 (a) Bed material scoured downstream of the structure**

**(b) Piles scoured to depths of 2.5m - 3m<sup>10</sup>**

The structure of the Murcia-bound carriageway, together with the two service roads, also experienced damage due to the flood. The pilot-operated piled foundations were barely affected by the flood, however scour of the surrounding soil resulting in removal of the surrounding soil and the piles were exposed to a depth of 2.5 m to 3 m, Figure 11.

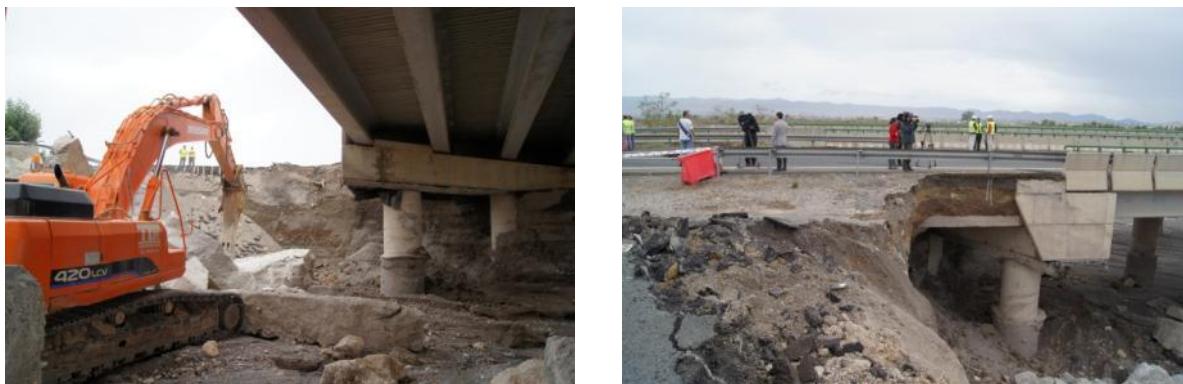
**Figure 12 General view and detail of the abutment nº 2 of the Murcia-bound carriageway and scour of the run-on slab<sup>10</sup>**

At the embankments and bank access to the structure, as result of the erosive action of the water, severe scour occurred under the run-on slab of Abutment 2 of the structure corresponding to the main Murcia-bound carriageway of the motorway, Figure 12. To compound this, the erosion of the closest access embankments, produced by the collapse of the adjacent abutment, and the erosive action of water, has an additive effect. The combined effects of both action produced a high uncertainty of geotechnical and structural behaviour of the access embankment which prevented the immediate restoration of the traffic.

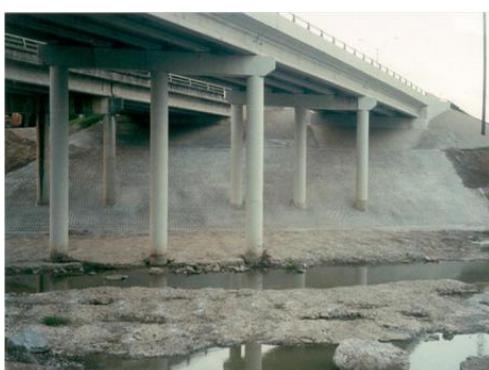
Figure 13 ArmorFlex erosion protection [11]<sup>11</sup>

Using a protective system, such as 'riprap', is one of the common methods to control the scour. Placing a riprap layer locally around the pier increases the resistance, and scouring around the pier can be prevented. Recent developments include a system which is designed to dissipate energy and resist the erosive forces of flowing water, protecting channel boundaries from scour and erosion Figure 13 and Figure 14.

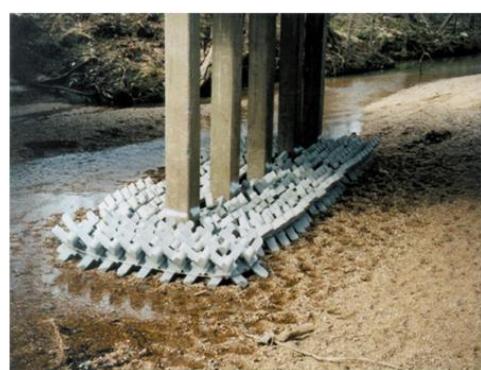
Figure 14 A-Jacks scour protection system [12]<sup>12</sup>

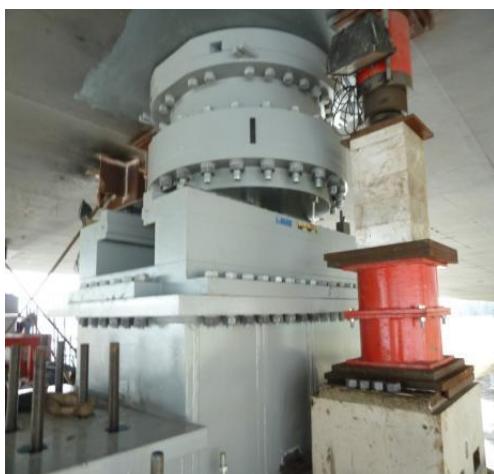
Figure 15 Installation of a RESTON-SPHERICAL UPLIFT bearing under bridge's raised deck<sup>13</sup>

In the case of bridge deck inundation, one remediation option is to ensure the deck is above the level of the flood. This can be achieved by 'raising' the bridge deck, a process whereby the bridge is lifted from its supports by powerful jacks. Invariably this will require the installation of new bearings. Equally this process can apply to the repair or replacement of damaged bearings (Figure 15).

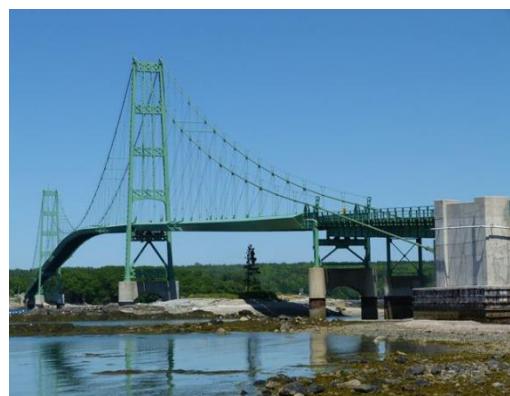
Figure 16 Deer Isle-Sedgwick Bridge and fairings designed in the FHWA<sup>14</sup>

In providing resilience against wind loading, a number of options are available to the engineer. One such method is to "stiffen" the bridge by the addition of cables and stays or stiffening existing girders. The Deer Isle-Sedgwick Bridge, Figure 15, is an example of a bridge that has been modified a number of times since its construction in 1939 due to concerns over the impact of wind loads. Initially, due to concerns over its 'instability' when subjected to wind loading a system of stay cable stays and floor stays were added to stiffen the girders. Subsequently, in the early 1990's, lightweight fibreglass fairings, were attached to the side of the main girders in order to provide further resilience against the wind. The fairings are triangular pieces that, in effect, "slice" the wind and ensure the air flows around the bridge smoothly (i.e. less eddies etc.).

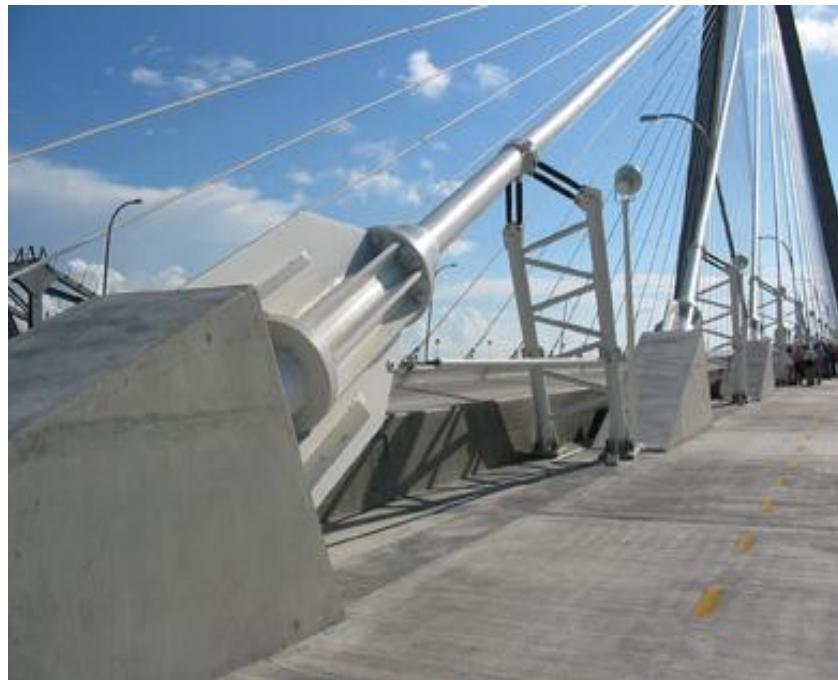
Figure 17 Ravenel Jr. Bridge in South Carolina and dampers <sup>13</sup>

Dampers can also be used to improve bridge resilience in order to mitigate against wind-induced cable vibrations. Figure 17 shows one of several types of dampers deployed on the Arthur Ravenel Jr. Bridge in South Carolina. A trussed support frame is anchored to the deck, and two pairs of viscous dampers are fastened to the top of the frame.

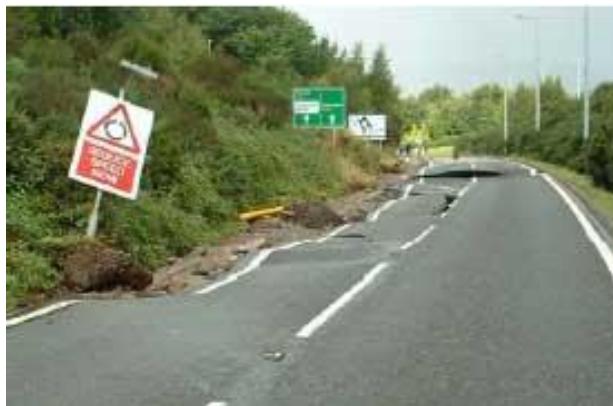
**Figure 18 Damage to A9 Raigmore Slip Road, Inverness (Scotland), 2002, following heavy rainfall.**  
 Photograph courtesy of BEAR Scotland Ltd.<sup>15</sup>

When an extreme weather event occurs, the pavement of the road network is often damaged. Nevertheless, only damage resulting in a complete loss of functionality of the road is generally reported. To illustrate this point, three cases of distress of the pavement are shown. All of them have taken place in the last 15 years around Europe, namely (a) damage to A9 Raigmore Slip Road, Inverness (Scotland), due to the heavy rainfall in 2002, Figure 18; (b) damage to a road in Kerry

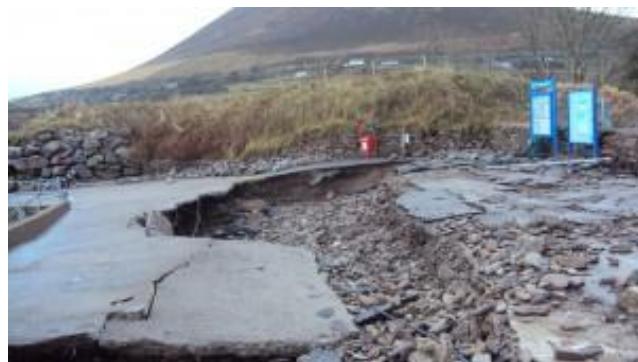
**Figure 19 Damage to a road in Kerry (Ireland) due to a windstorm and heavy rainfall, January (2014).**  
 Photograph courtesy of radiokerry.ie<sup>16</sup>

(Ireland) due to a windstorm and heavy rainfall in January 2014, Figure 19); and (c) damage to A-139 Benasque-Cerler (Spain) due to Ésera river flooding in June 2013,Figure 20.

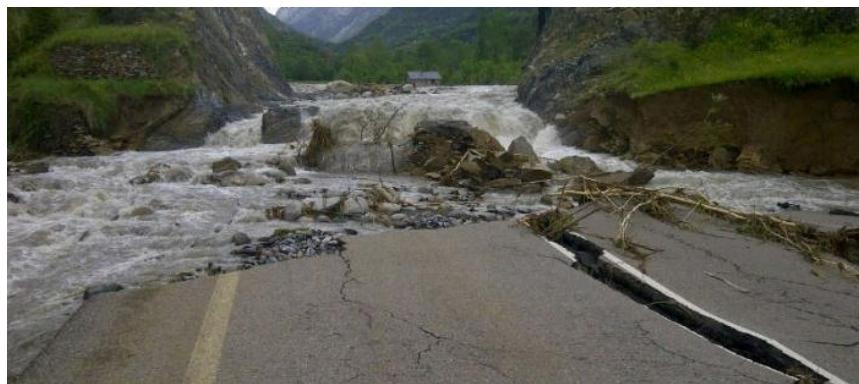
**Figure 20 Damage to A-139 Benasque-Cerler (Spain), June 2013, due to Ésera river flooding. Photograph courtesy of Heraldo.es<sup>17</sup>**

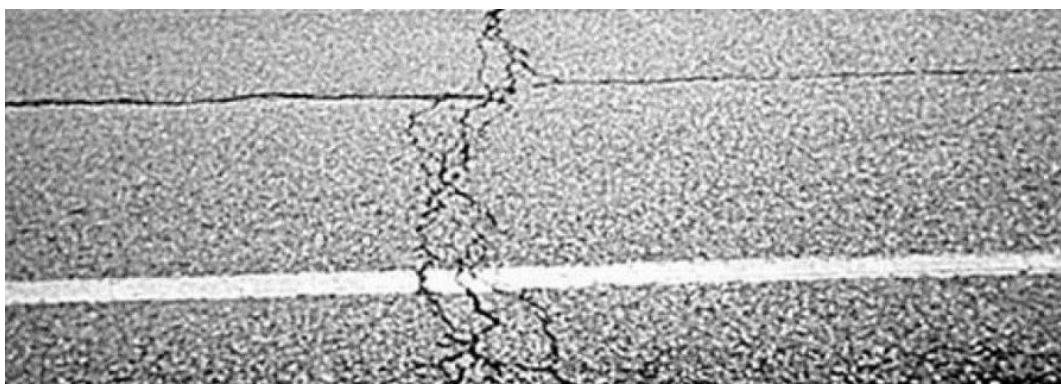
**Thermal cracking (transverse cracking):** a series of cracks evenly spaced perpendicular (transverse) to the flow of traffic. There are two types of thermal cracks - those occurring during a single falling temperature event (i.e. ice storm), and those caused from damage accumulated after repeated temperature cycling. Cracks appear usually over the entire pavement, not just in wheel paths. It is not an indication of structural failure. It can be caused by sharp temperature drops.

Figure 21 Thermal cracking<sup>18</sup>

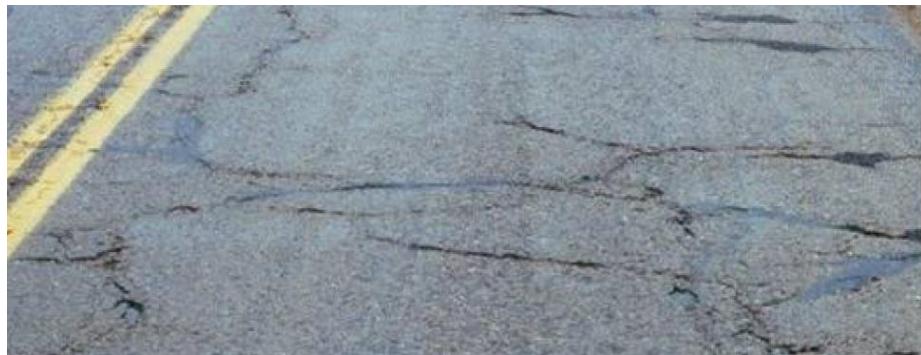
**Premature aging surface:** Minimal visual signs of distress on the surface. The underlying structure remains in good condition. This type of distress can be caused by exposure of the pavement, over time, to both traffic and environmental factors (e.g. weather etc.)

**Figure 22 Premature aging surface<sup>18</sup>**

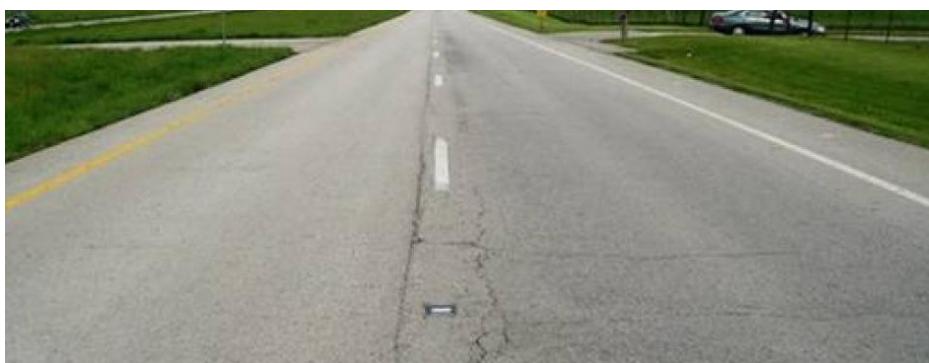
Longitudinal Cracking (Wheel Path Cracking): Cracking in the direction of flow of traffic, usually at the edge of wheel paths. It can be caused by heavy traffic and an unstable base.

**Figure 23 Longitudinal Cracking<sup>18</sup>**

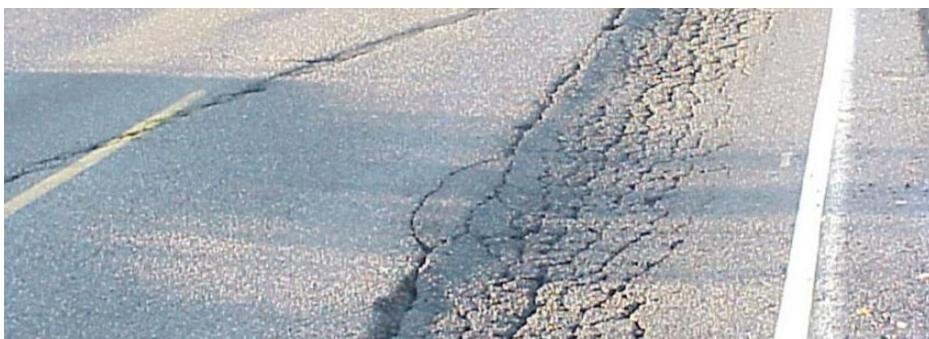
Rutting: Permanent deformations of the pavement (indentations) in the wheel paths, which can lead to cracking and further deterioration. It can be caused by heavy traffic and extreme temperatures.

**Figure 24 Rutting<sup>18</sup>**

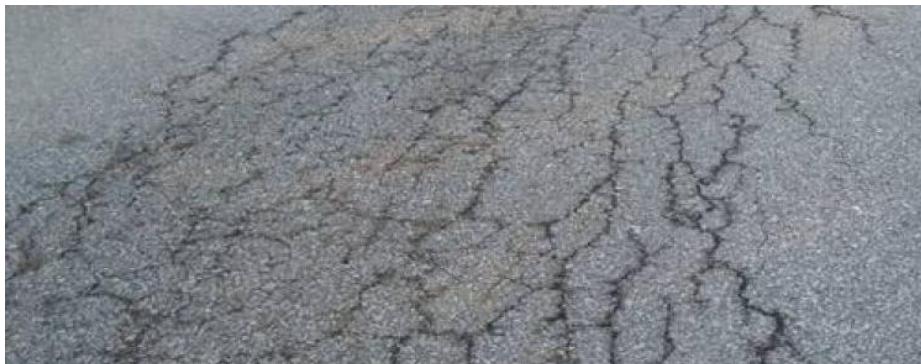
Fatigue cracking (Alligator cracking): Interconnected cracking with a pattern resembling alligator skin. It is typically found in wheel paths and may be accompanied by rutting. It can be caused by accumulated damage, age hardening, and poor drainage.

**Figure 25 Fatigue cracking (Alligator cracking)<sup>18</sup>**

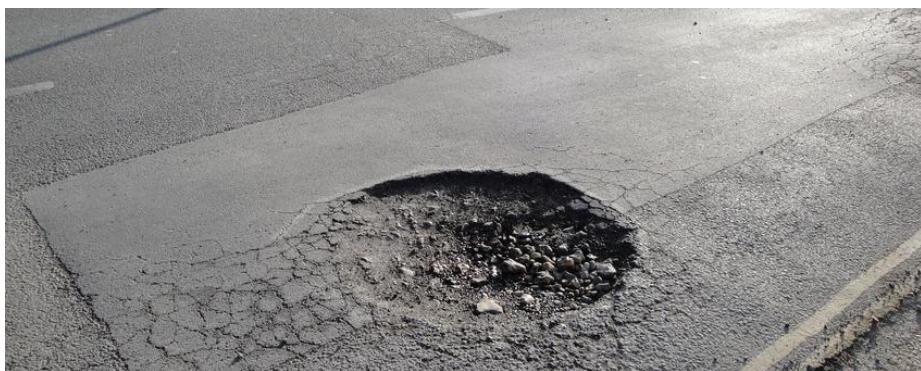
**Potholing:** Holes in pavement usually formed when water gets into cracks and destroys the underlying structure. It can be caused by accumulated damage, age hardening, and poor drainage.

**Figure 26 Potholing<sup>18</sup>**

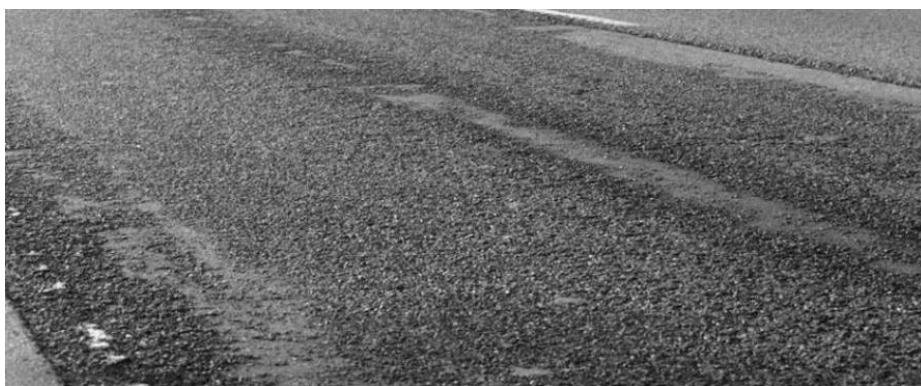
**Ravelling:** Loose materials (usually aggregate) that “ravel” from the surface or edges of the pavement, resulting in depressions which may fill with moisture and loose aggregate which may pose problems. It can be caused by snowplough damage, and intensive traffic.

**Figure 27 Ravelling<sup>18</sup>**

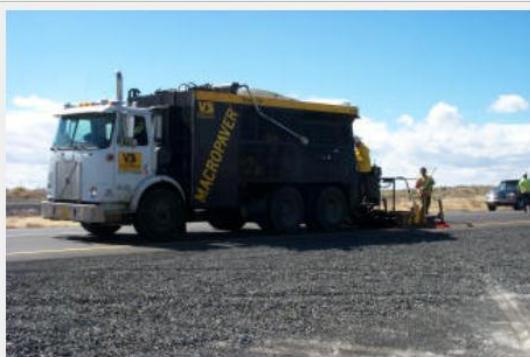
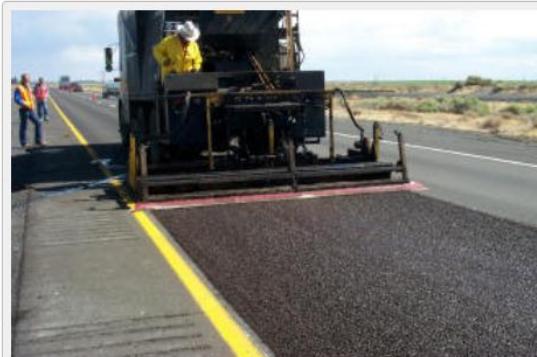
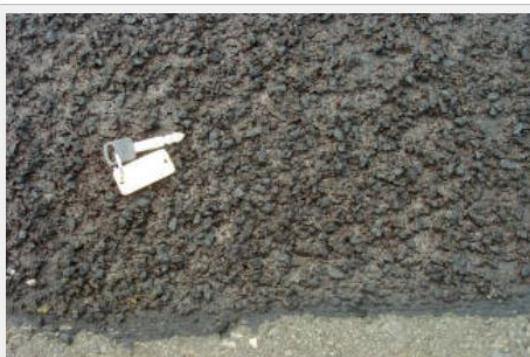
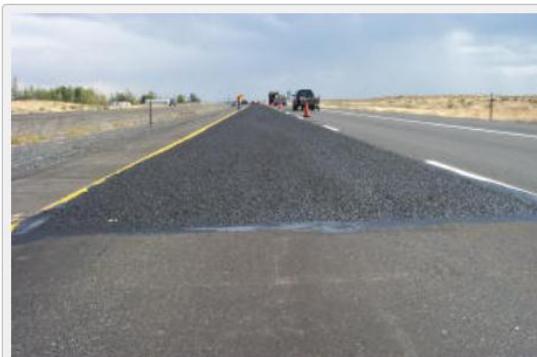
Figure 1: Ignition method major equipment.

Figure 2. Microsurfacing placement.

Figure 3. Microsurface close-up.

Figure 4. Finished microsurface.

#### **Figure 30 Application of microsurfacing slurry<sup>19</sup>**

Micro surfacing, Figure 30, consists on applying a homogenous mixture of emulsified asphalt, water, well-graded fine aggregate, mineral filler and advanced polymer additives. It is used to fill existing pavement surface defects as either a preparatory treatment for other maintenance treatments or as a wearing course.

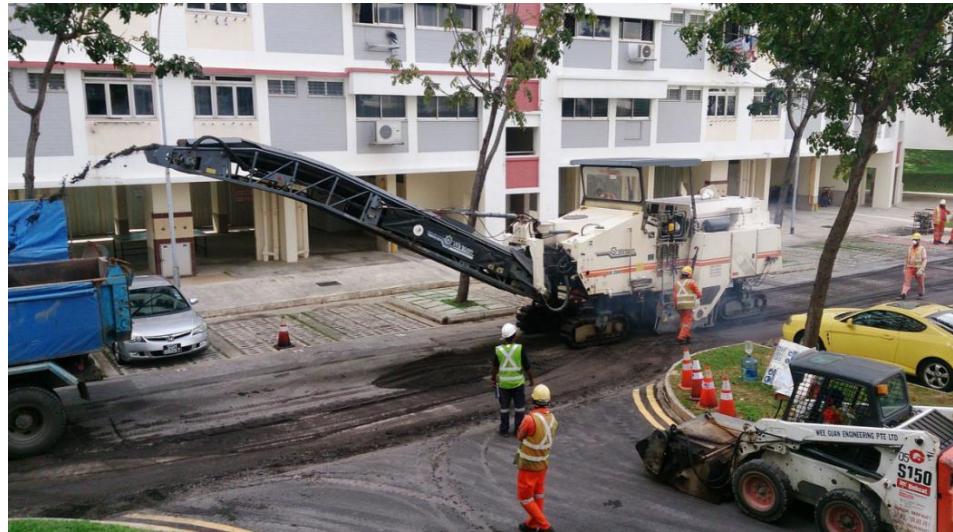
**Figure 31 Asphalt road being milled<sup>20</sup>**

Milling and filling. Milling, also called grinding or cold planning, is used to remove a distressed surface layer from an existing pavement. The depth of the intervention will depend on the degree of the damage. Milling machines are generally used to remove the top layers. Afterwards, the surface is cleaned off by sweeping or washing to prevent the dirt and dust decreasing the bond between the new overlay and the existing pavement. Finally, new layers are built according the new requirements.

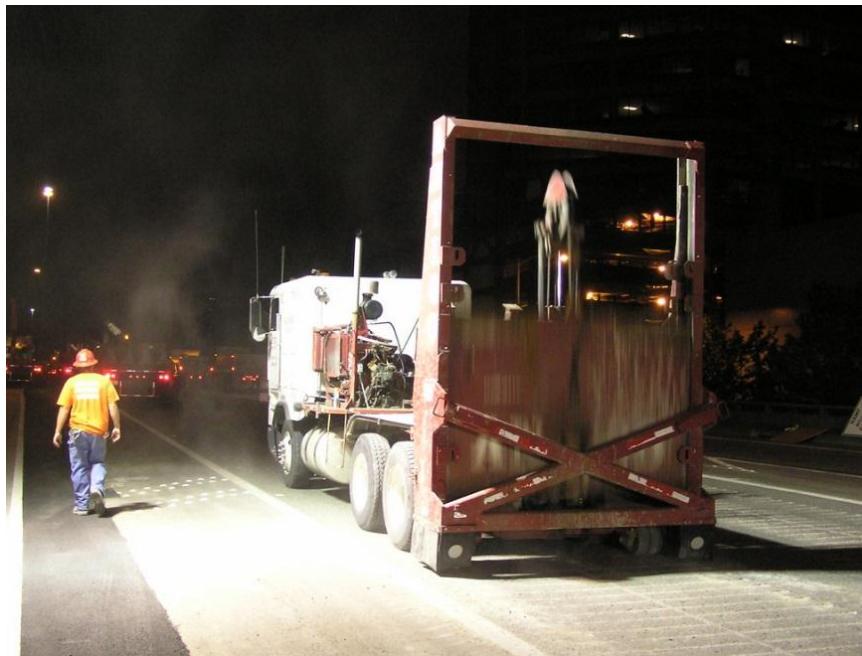
**Figure 32 Drop hammer<sup>19</sup>**

Crack/break and seat involves breaking the underlying PCC pavement into relatively small pieces (on the order of about 0.3 m<sup>2</sup> to 0.6 m<sup>2</sup>) by repeatedly dropping a large weight, Figure 17. The pieces are then seated by 2 to 3 passes of a large rubber tired roller. The result is a pavement made of small firmly-seated pieces. This technique is used to prevent, or at least delay, the onset of reflection cracking in the HMA overlay caused by the large differential movement at slab and crack interfaces.

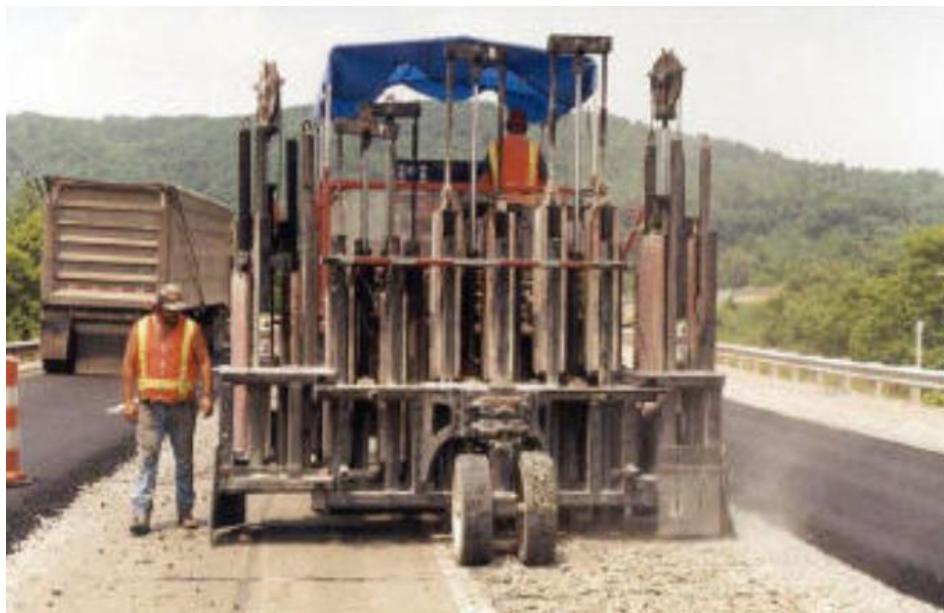
Figure 33 Multi-head breaker <sup>19</sup>

Rubblization involves reducing the underlying PCC pavement to rubble. This rubble is then used as a high quality base course to support the HMA overlay. Rubblizing is typically done with one of the following two pieces of equipment; (a) resonant pavement breaker, which strikes the rigid pavement at low amplitude with a small plate at the resonant frequency of the slab; and (b) multi-head breaker (see Figure 33), which uses a series of independently controlled high amplitude drop hammers to smash the slab. Typically, there are between 12 and 16 hammers. This technique, as that presented before, is used to prevent, or at least delay, the onset of reflection cracking in the HMA overlay caused by the large differential movement at slab and crack interfaces.

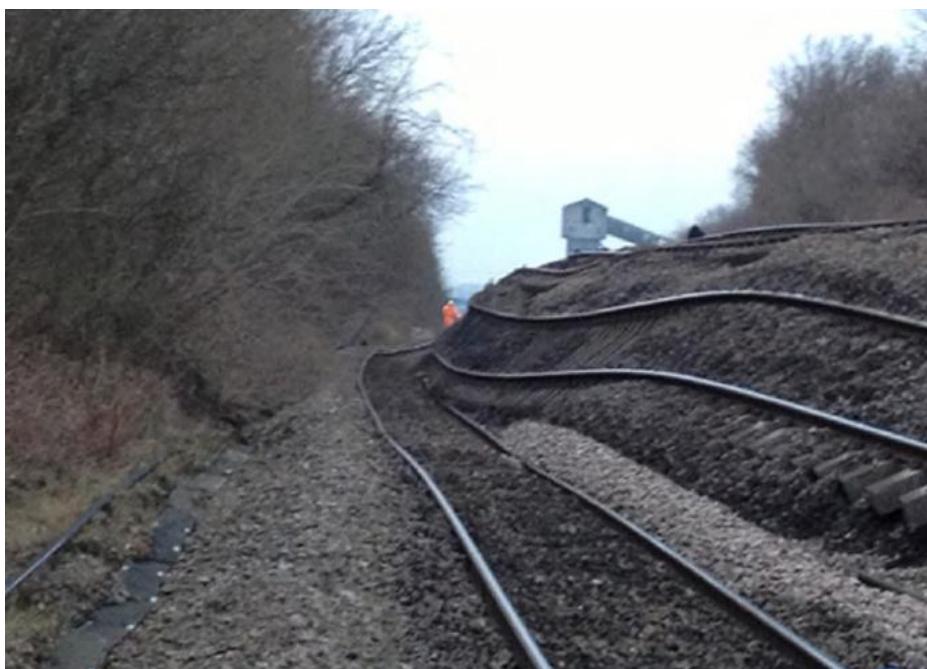
Figure 36 Rail track deformations in Hatfield Colliery [23]<sup>23</sup>

The UK Rail Accident Investigation Branch (RAIB) reported on a major slope failure that occurred on the 11th of February 2013, in Hatfield Colliery, in South Yorkshire. The landslide resulted in major deformation to the rail track, Figure 36. The initial movements were noted a couple of days before so there were no damage to trains and no injuries. However major works were required to remediate the track and traffic was not reopened until the 6<sup>th</sup> of July 2013.

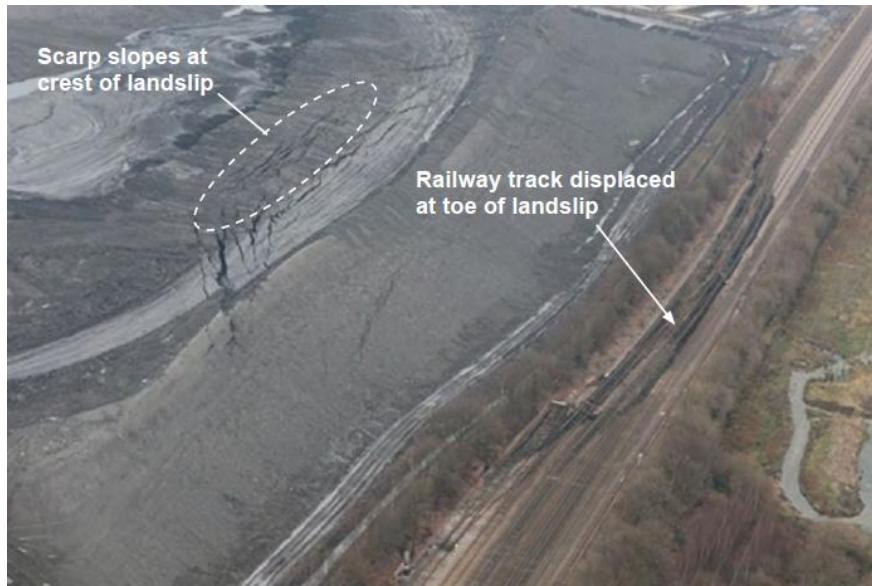
Figure 37 Aerial view of the landslide<sup>23</sup>

According to aerial photos taken by Network Rail, Figure 37, the track deformation happened due to a large landslip caused by spoil tip located outside the railway boundary, and within Hatfield Colliery (coal mines).

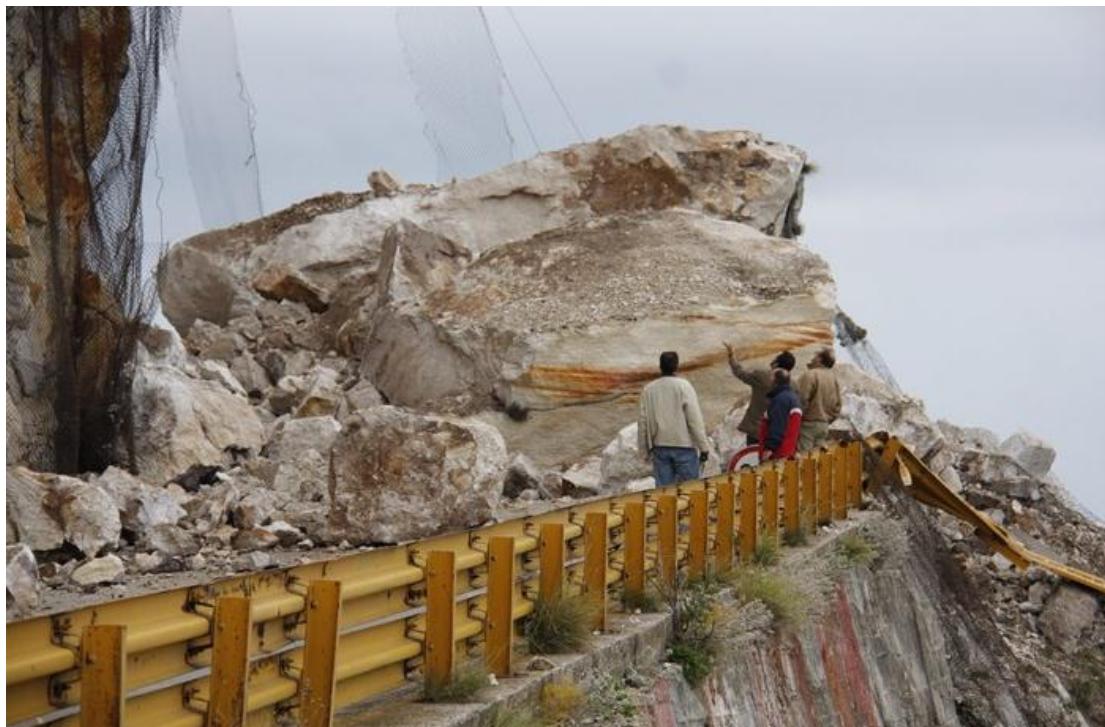
Figure 39 Rock fall near city of Makarska <sup>24</sup>

A major rock fall occurred on the regional road D-512 Makarska-Vrgorac, in Croatia on the 24<sup>th</sup> of October 2010, Figure 39. Prior to the large rockfall, smaller boulders were displaced and the road was cleared and warning signs were erected. The location had suffered a major rockfall two decades before. The boulder shown weighed several thousand tons, however due to the earlier occurrence of smaller rockfall, the road was not operational and nobody was injured. A survey of the rock surface determined that major remediation was required to the area. The slope was so unstable that an alternative route requiring the construction of a two lane road tunnel, Figure 40, was constructed, in order to bypass the critical area. Reinforced concrete galleries were constructed at each end of the tunnel along with rockfall nets and drapes accompanied by monitoring devices.

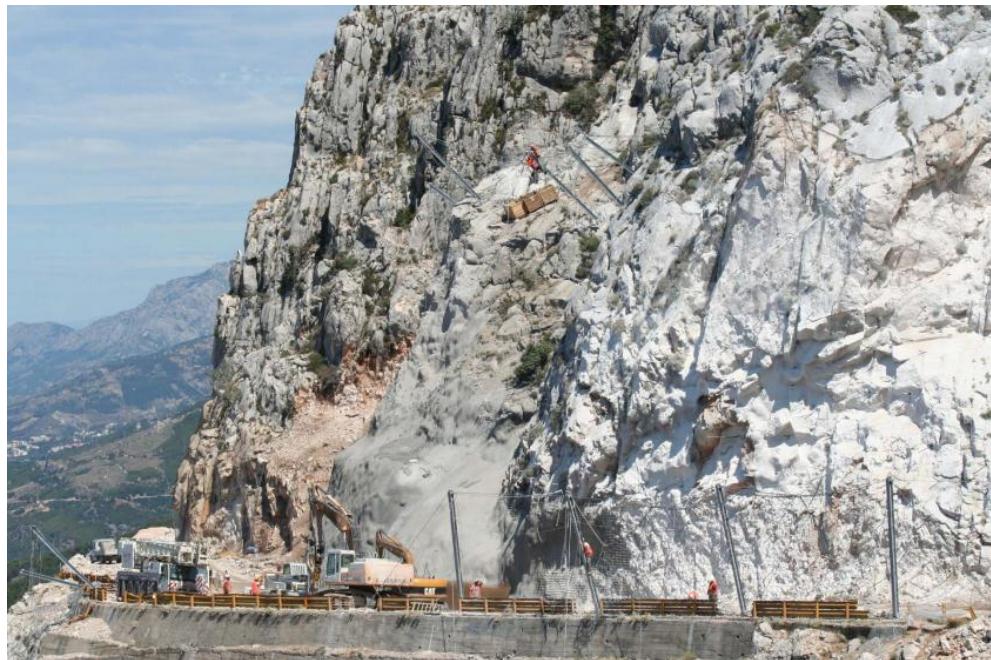
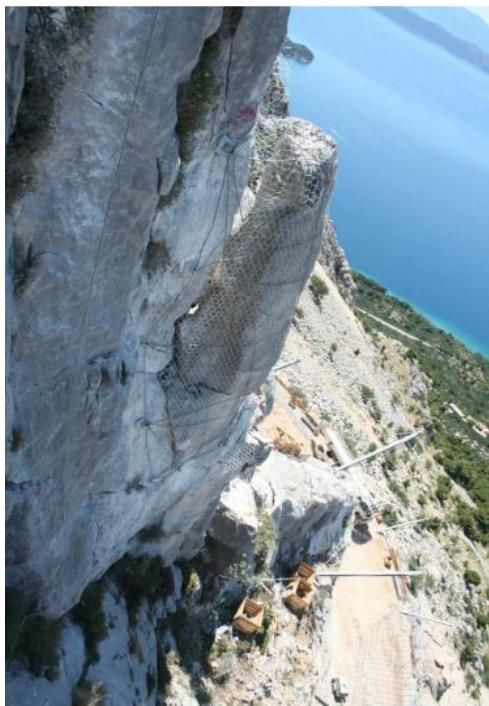
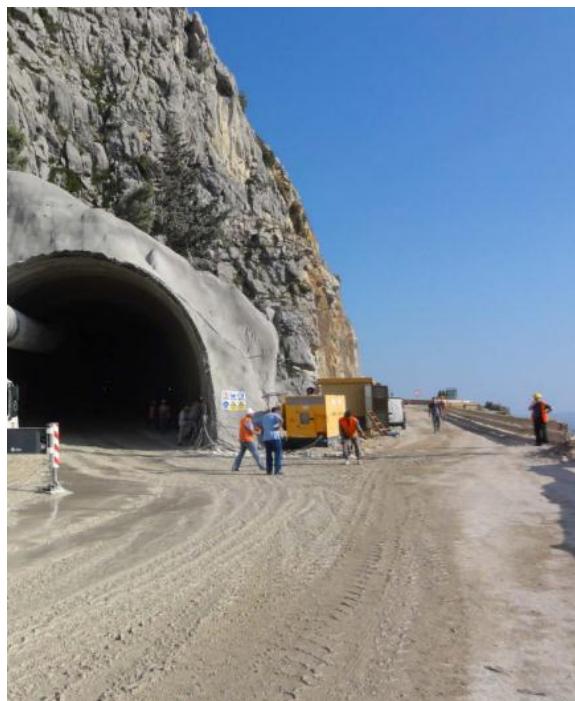
**Figure 40 (a) rockfall nets and shotcrete covers, (b) drapes (c) tunnel bypassing a critical road segment<sup>25</sup>**

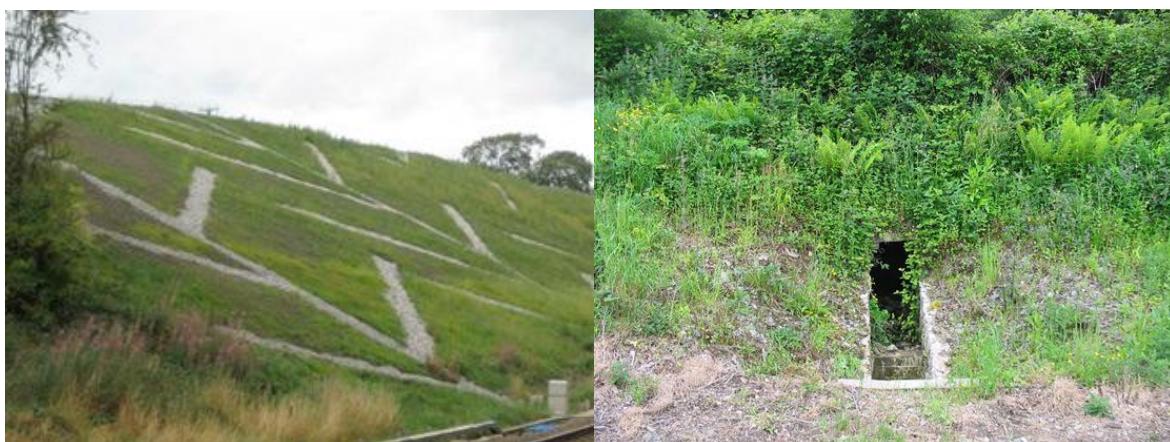
Figure 45 (a) Herringbone drainage system in rail cutting<sup>28</sup> (b) Surface drainage culvert on an Irish Rail cutting<sup>29</sup>

**Drainage:** Surface drainage techniques commonly adopted for transport infrastructure networks include lined and unlined open ditches, buried drains such as herringbone drains, Figure 45. The latter are relatively cheap to install and are relatively effective at controlling suctions at depth of up to 1.5 m particularly in more temperate climates.

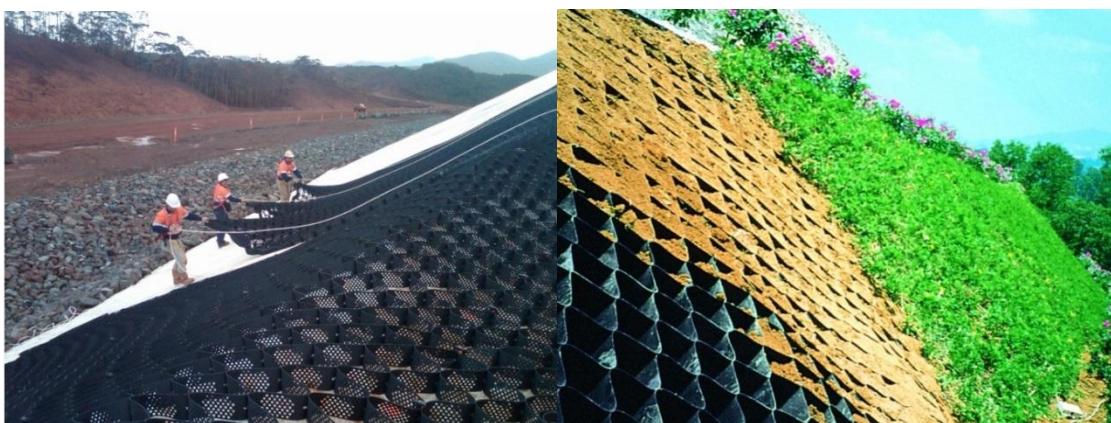
Figure 48 (a) Engineered slope (b) Stabilisation of natural slope

On steep engineered slopes the development of vegetation can be aided by the introduction of geocell mattresses, Figure 48. These allow the establishment of vegetation on steep slopes and inhospitable conditions. In addition to providing added stability they improve the aesthetic condition.

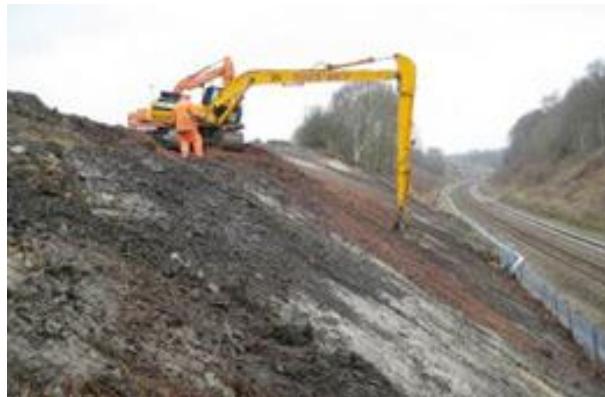
Figure 49 Slope regrading<sup>33</sup>

Measures which can be taken to increase the resistance of the slope or reduce the disturbing force include, slope re-grading, soil improvement and structural inclusions (piling and soil nailing). One of the cheapest methods of increasing the factor of safety of an existing slope is to reduce the slope angle by re-grading, Figure 49. Whilst this can substantially reduce the disturbing force, the additional footprint required often precludes the adoption of this measure on existing networks.

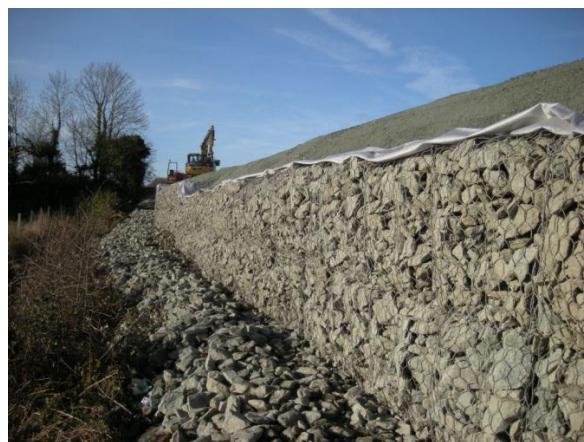
Figure 50 Irish Rail Embankment remediation<sup>34</sup>

Where space constraints dictate, the provision of gabion baskets, Figure 49, can effectively allow for re-grading of the upper slope, whilst maintaining the existing slope footprint.

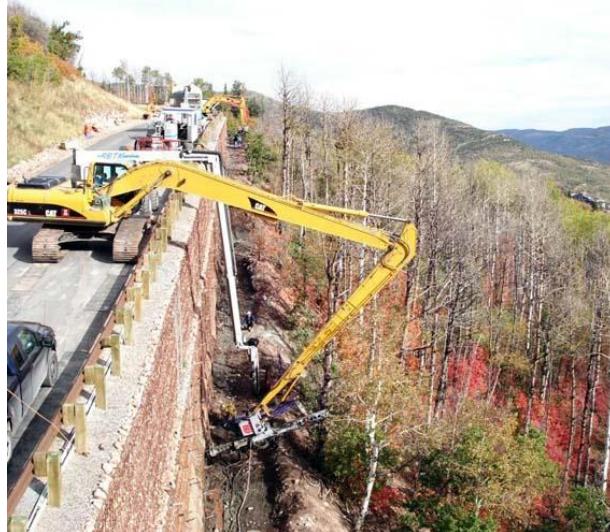
Figure 53 Soil Nails (a) Soil slopes<sup>37</sup> (b) Rock Slopes<sup>38</sup>

Structural solutions in the form of piles and soil nails tend to be expensive, however, they are an effective way of upgrading existing slopes where space constraints might preclude other solutions. The piles work by providing additional lateral shear resistance by intersecting potential failure surfaces (Figure 52), whilst soil nails are essentially tension members (high strength steel bars encased in grout) which are drilled far beyond the potential failure surface and provide additional anchor forces to prevent failure. Some form of load transfer mechanism on the slope surface is required with the anchor system; Figure 53a. Anchoring solutions are particularly effective for stabilising fractured rock slopes, Figure 53b.
