<b>Deliverable Reference</b>	<b>D 7.1</b>
<b>Deliverable Name</b>	<b>Analysis of practical remediation strategies for discrete infrastructure systems</b>
<b>Contributing Partners</b>	<b>GDGEO</b>
<b>Date of Submission</b>	<b>August 2015</b>

RAIN – Risk Analysis of Infrastructure Networks in Response to Extreme Weather

# Analysis of Practical Remediation Strategies for discrete Infrastructure systems

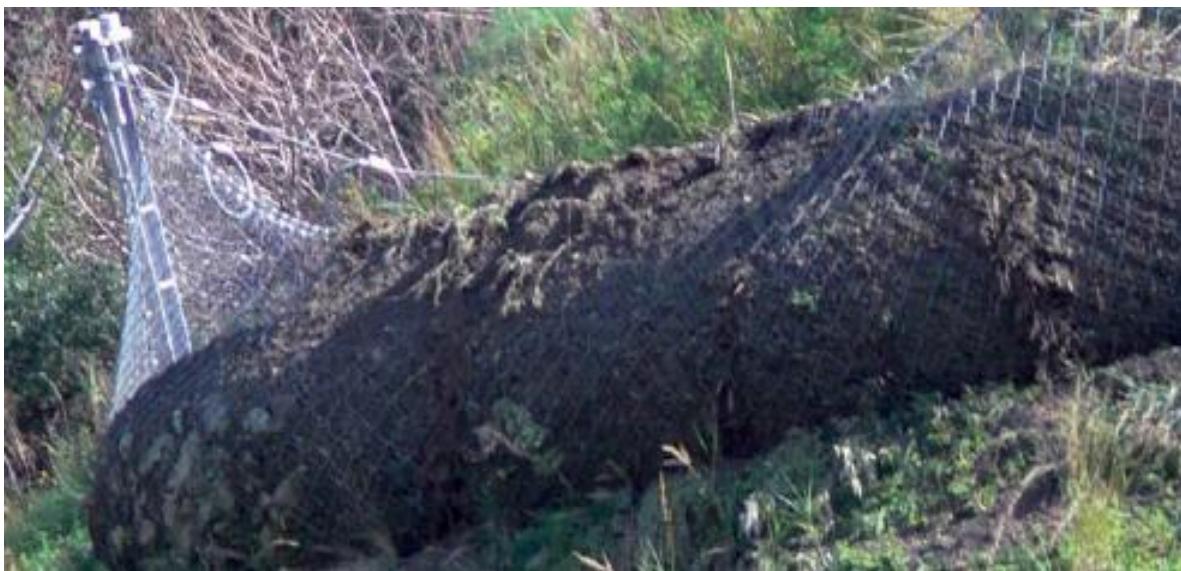
**Figure 54 Shallow landslide barrier** <sup>39</sup>

Shallow landslide barriers consist of posts which facilitate and guide spiral rope nets and protective mesh apron (which serves as an erosion seal between the ground and the barrier). Spiral rope nets are anchored into the ground by spiral rope anchors and brake rings are incorporated in the support and the retaining ropes. Once the major event happens the breaks are activated thus enabling the net and the ropes to safely lock-in the soil.

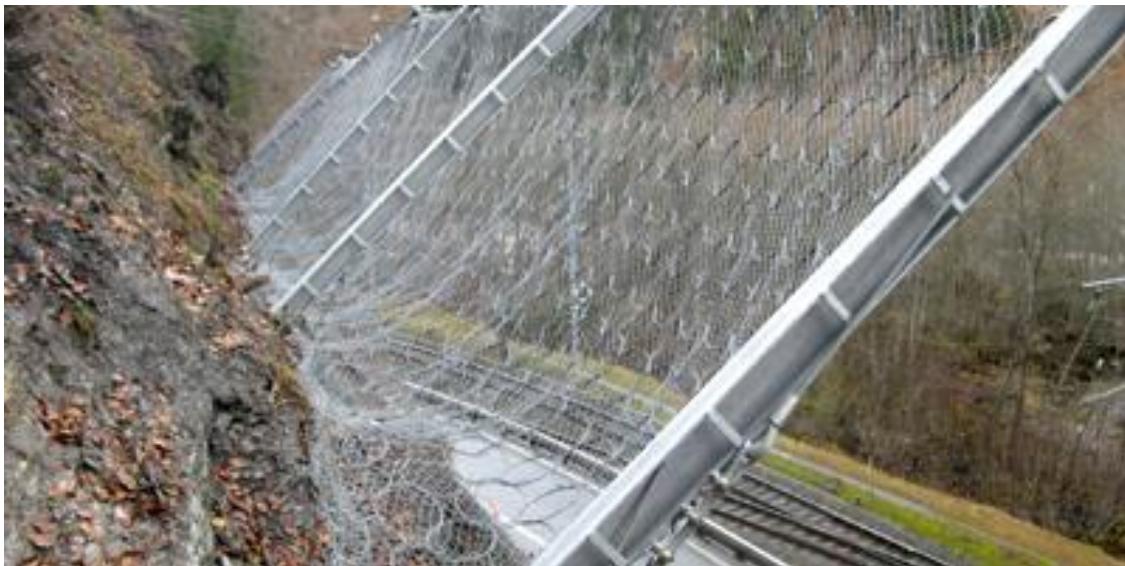
Figure 55 Rockfall net<sup>39</sup>

Rockfall nets act on a similar principal to shallow landslide barriers. The difference is in the catchment net, which is constructed according to rock impact and is usually made of interlocked rings, Figure 55.

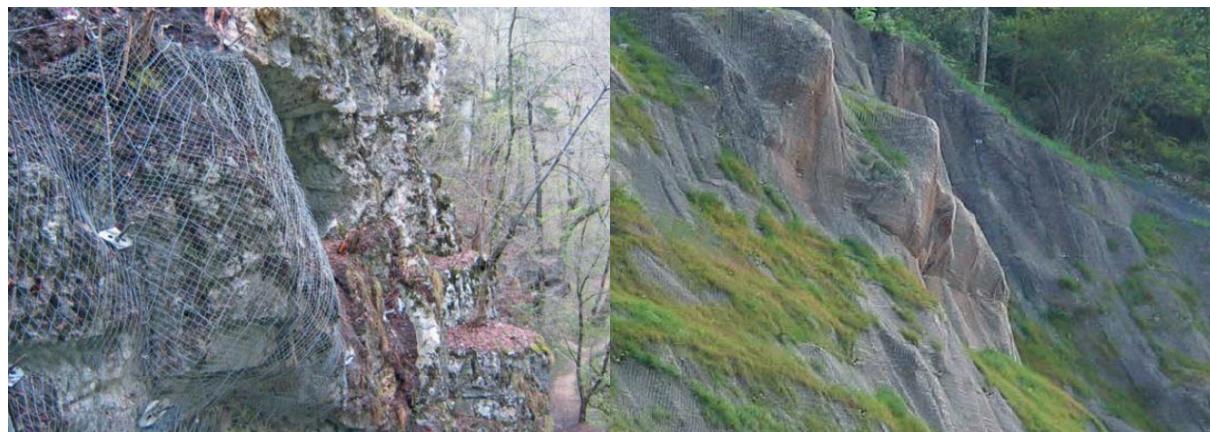
Figure 56 (a) Wire drape rapped around irregular surface, (b) Wire drape with seeding<sup>39</sup>

Drapes are used to mitigate the impact of rock sliding on rock slopes and to secure the loose rock even on irregular surfaces. The main difference between the classic net and the drape is in the flexibility. Drapes wrap around irregular surfaces, Figure 56a, and offer more coverage with the rock interface. Some of the drapes have an incorporated erosion control mat which allows both dry and wet seeding, Figure 56b.

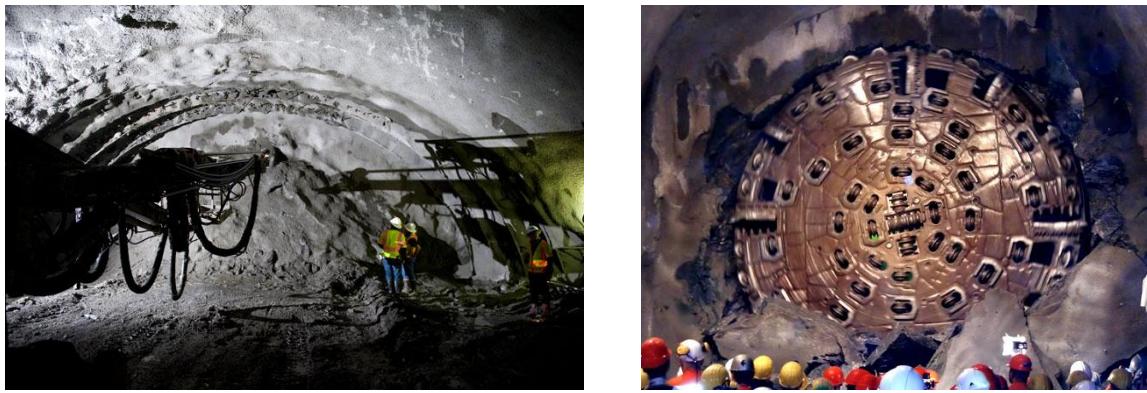
Figure 72 Rock Tunnel (a), Soft Ground Tunnel (b)<sup>53</sup>

The two most common methods used in tunnel construction are the (a) New Austrian Tunnel Method (NATM), Figure 72, and (b), the Tunnel Boring Machine (TBM),Figure 72. . In NATM the tunnel is sequentially excavated and supported, with the initial ground support provided mostly by anchors and shotcrete. Permanent support typically consists of a cast-in-place concrete lining with a waterproof membrane. In contrast, TBM progresses through the ground with a cutter head, followed by a main bearing, thrust mechanism and trailing support mechanism (back-up system in the finished part of the tunnel, containing slurry pipelines, control room, electrical system, ventilation, mechanism for transport of pre-cast tunnel lining segments etc.).

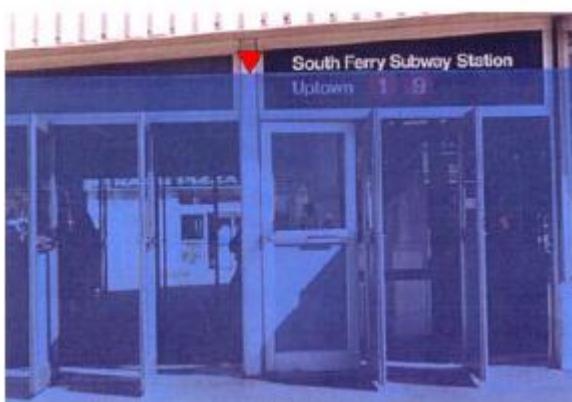
**Figure 77 Potential Category 2 hurricane surge at South Ferry (Battery Station)<sup>60</sup>**

MNYHTS (1995) illustrates the expected flood levels, Figure 77-Figure 80, in this area and at other key locations in New York and New Jersey by superimposing them onto photographs for selected facilities.

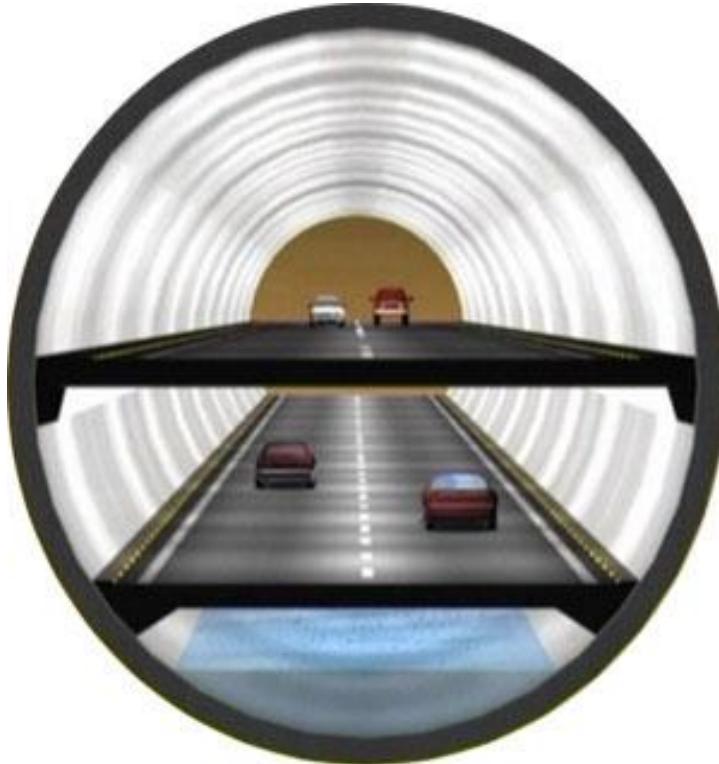
Figure 81 SMART Tunnel in Kuala Lumpur<sup>61</sup>

Figure 81. There are two components of this tunnel, the storm water tunnel and motorway tunnel. It is the longest multi-purpose tunnel in the world. It was opened on May 14th 2007, after 4 years of construction, it handles 30 000 cars per day and has been used 44 times to divert floodwater.

The tunnel has three modes of operation. In the first mode, under normal conditions where there is no storm, no flood water will be diverted into the system. In the second mode, when flooding occurs, the flood water is diverted into the bypass tunnel underneath the motorway tunnel. The

motorway section is still open to traffic at this stage. In the third mode, when flooding is severe, the motorway will be closed to all traffic. After making sure all vehicles have exited the motorway, automated water-tight gates will be opened to allow flood waters to pass through. The motorway will be reopened to traffic within 48 hours of closure.

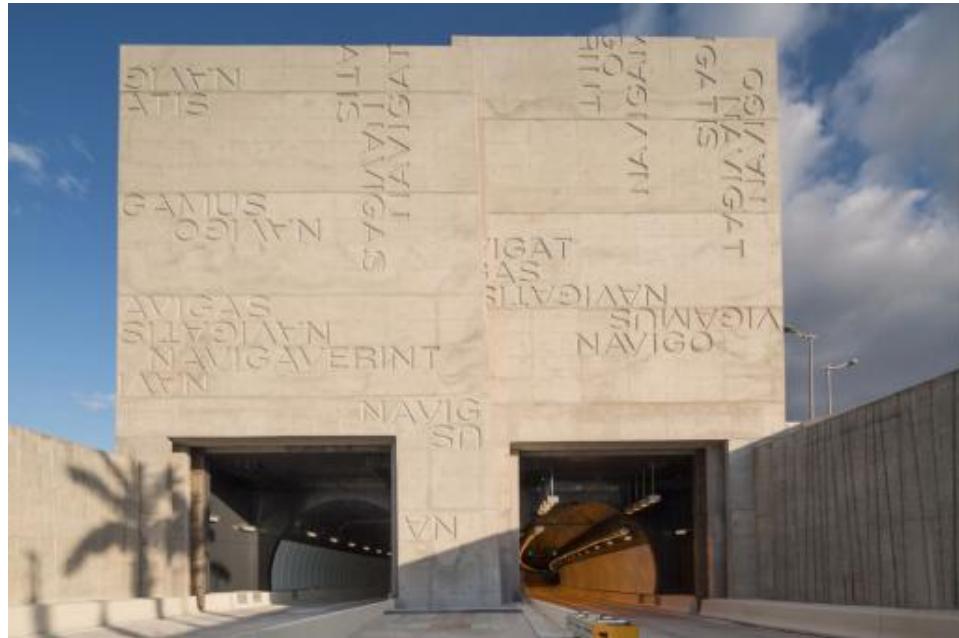
Figure 82 Port of Miami tunnel flood gates<sup>62</sup>

The Port of Miami Tunnel, Figure 82 is the result of a Public Private Partnership between Bouygues Travaux Publics and Meridiam Infrastructure (Private) and Florida Department of Transportation, Miami-Dade County and the City of Miami (Public).

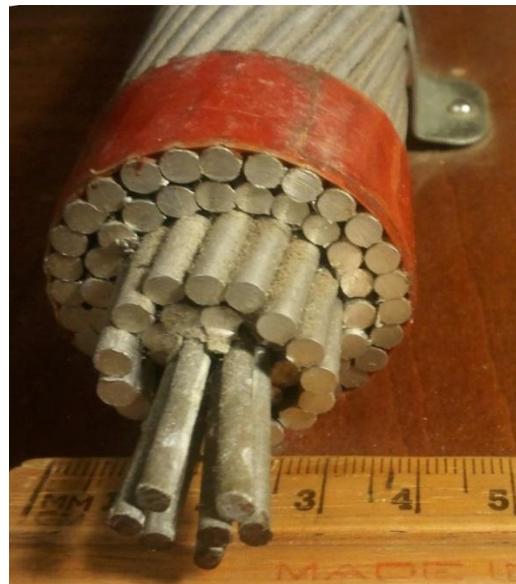
**Figure 83 Typical high-voltage power conductor, consisting of seven strands of steel surrounded by four layers of aluminium<sup>63</sup>**

In addition to the tower and the conductors, Figure 83-Figure 85, a third important element of any transmission or distribution line is the concept of “right-of-way”, Figure 86. In simple terms, the right of way is the strip of land immediately below and adjacent to a transmission line. The width of a right of way varies by the type of line – again, the higher voltage, the wider the rights of way. The typical corridor widths, unless otherwise specified in the right of way agreement, are as follows:

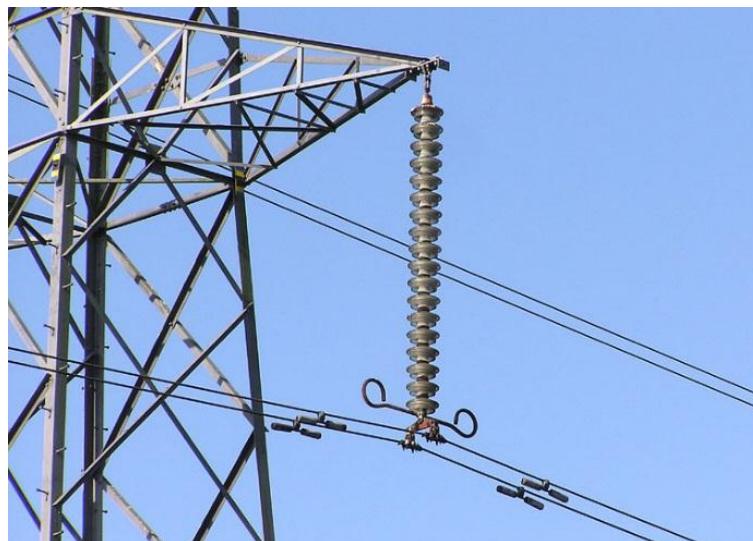
**Figure 84 Modular suspension insulators used for high-voltage lines<sup>64</sup>**

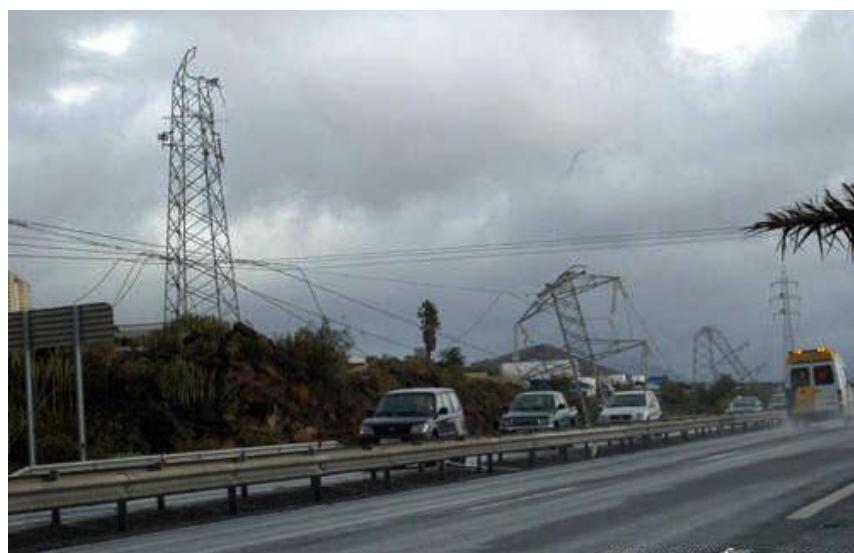
**Figure 87 Effects of tropical storm Delta in the Canary Islands, 2005** <sup>67</sup>

The tropical storm Delta was formed in the Atlantic, near the end of the hurricane season. Instead of moving west towards the Caribbean, as it is typical of these hurricanes, it first followed an erratic path before finally heading northeast, hitting the Canary Island with devastating consequences, Figure 87. The storm claimed nineteen lives and caused a total of €312 million damage throughout the archipelago. The electric infrastructure was hit particularly hard, mostly due to inadequate maintenance of pylons, as later enquiries revealed. About 300,000 electricity customers were affected by blackouts, which lasted several days.

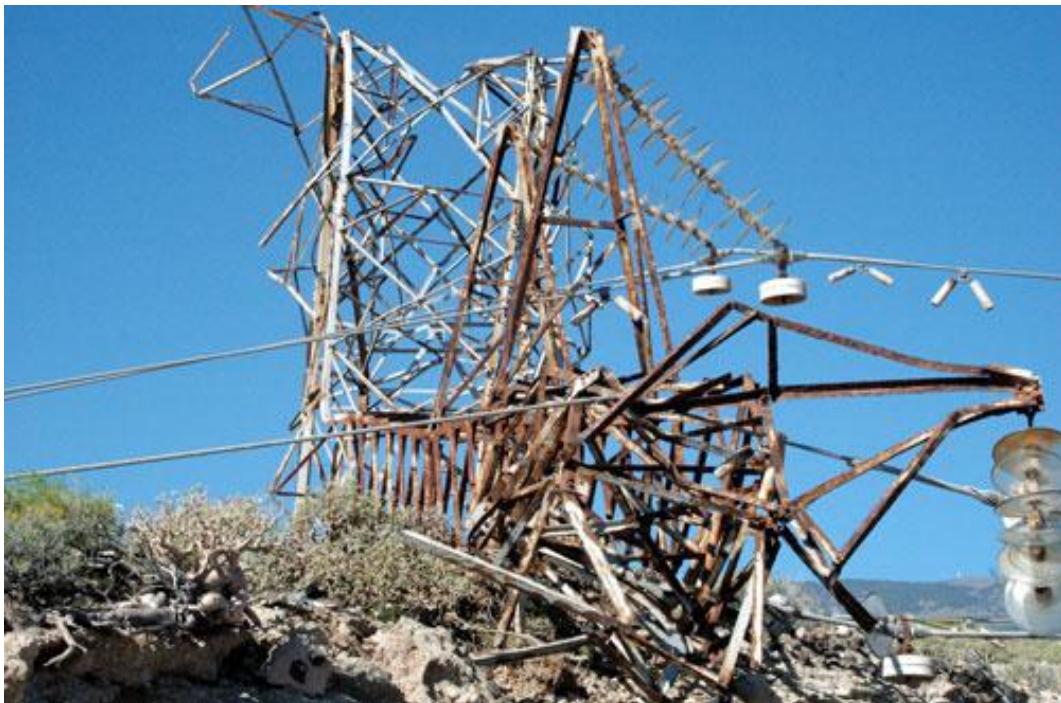
Figure 88 Toppled pylon in the Canary Islands event, clearly showing its rusted condition<sup>68</sup>

Thousands of homes were left without electricity as rusted pylons were blown down, Figure 88. The wind toppled or wrecked 39 high voltage pylons and no less than 103 medium voltage ones (1000-50000 V). The corroded condition in which the fabric of those structures were found to be in provoked little short of a major scandal and various institutions initiated legal proceedings and enquiries against Unelco-Endesa, the transmission and distribution utility.

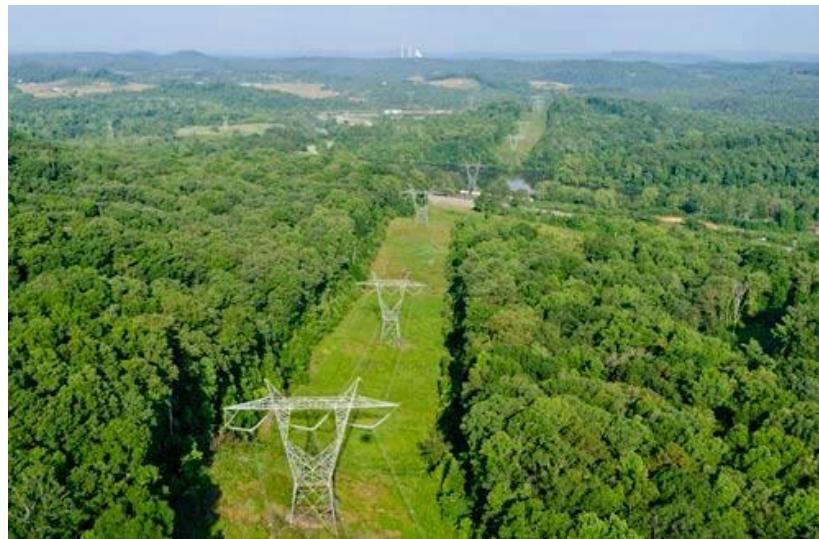
**Figure 90 Rights-of-way of a high voltage transmission line**<sup>70</sup>

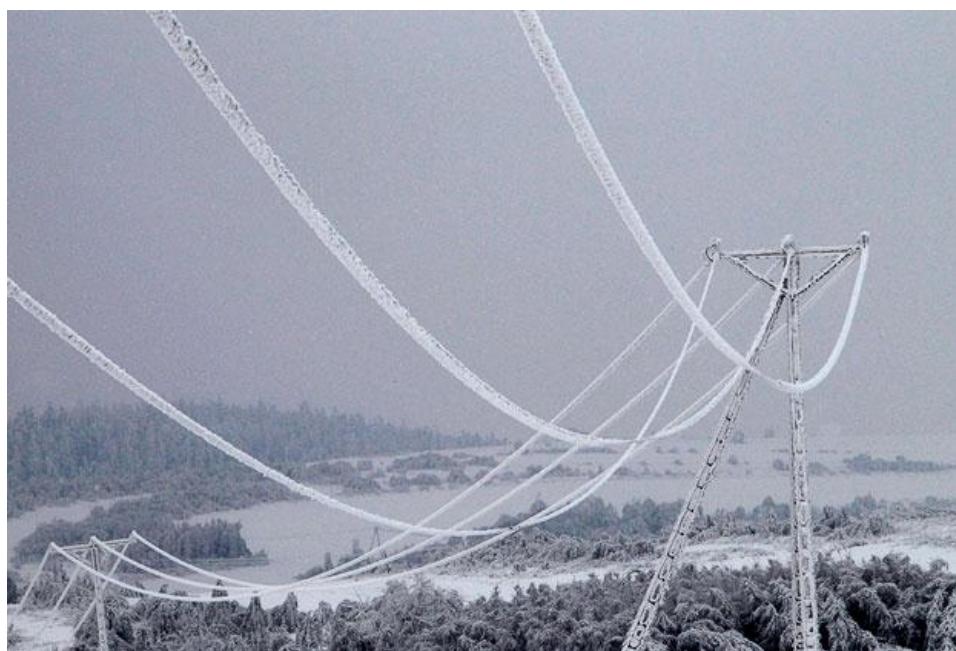
**Figure 91 Power lines covered in ice near the village of Skala in Poland. Around 27000 people were left without electricity due to electrical cables breaking from the weight of accumulated ice, in January 21, 2010**

Icing formation on structures and power lines is an important consequence of extreme weather that causes damage in many countries. Accumulated ice can weigh the lines down and cause ground faults. Also, ice suddenly breaking off the line can make the line whip and snap. On lattice towers accumulated ice can add a considerable amount of weight and make the tower crumble.

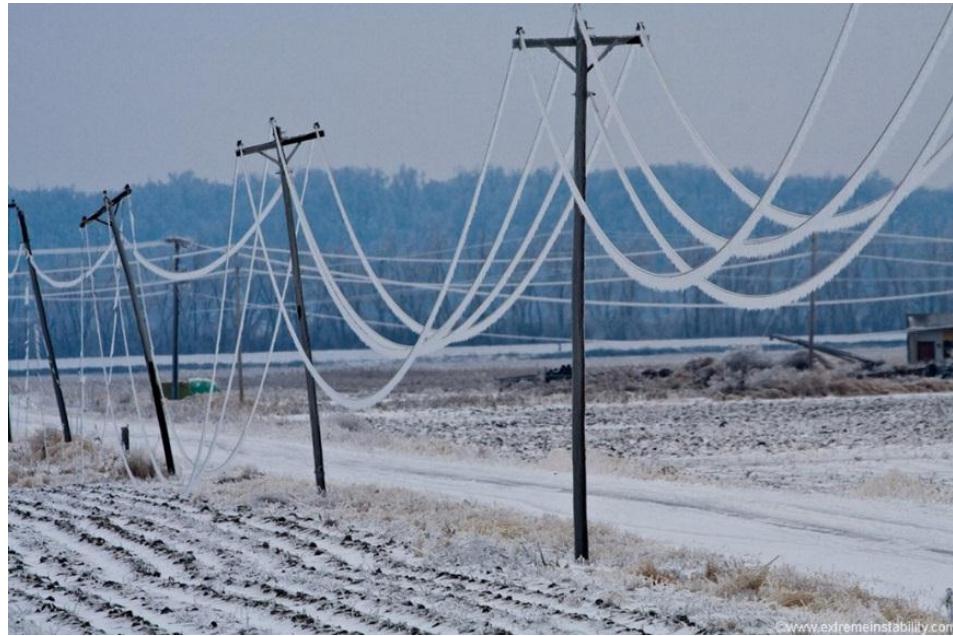
Figure 92 Line sag produced by the weight of ice produced a ground fault in this medium-voltage line <sup>72</sup>

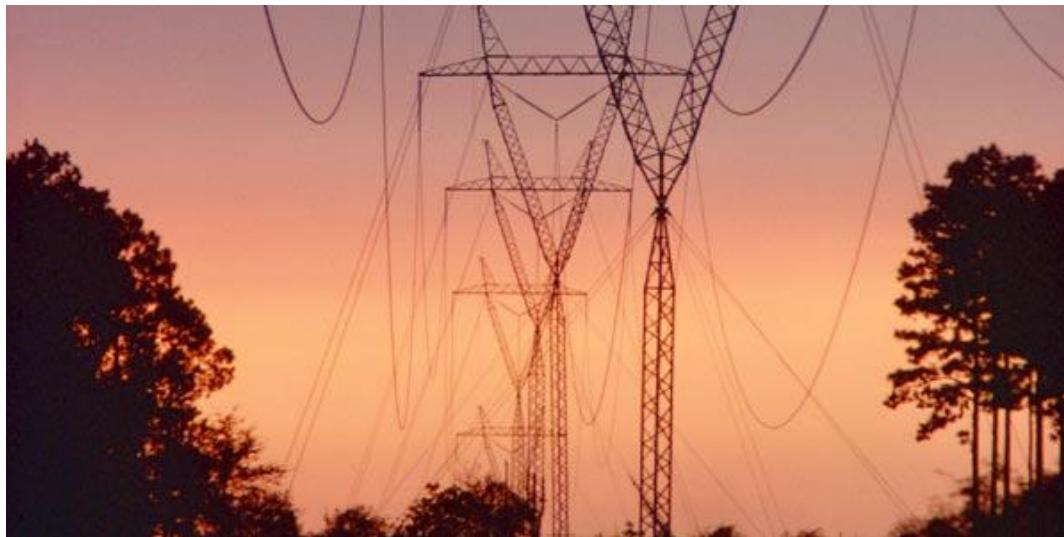
Figure 93 Excessive line sag produced by thermal effects <sup>73</sup>

Line sagging prevention/mitigation addresses mainly extreme heat. When lines carry electric power, they heat up due to the Joule effect, since they have some non-negligible resistance. The cables then dilate, causing sagging, Figure 93. Under extreme heat weather, particularly with low wind speeds, the line exchanges a lot less heat with the air around it, and the dilation could reach dangerous levels. Short of re-fitting the line with new cables (re-conductoring), some mitigation measures exist:

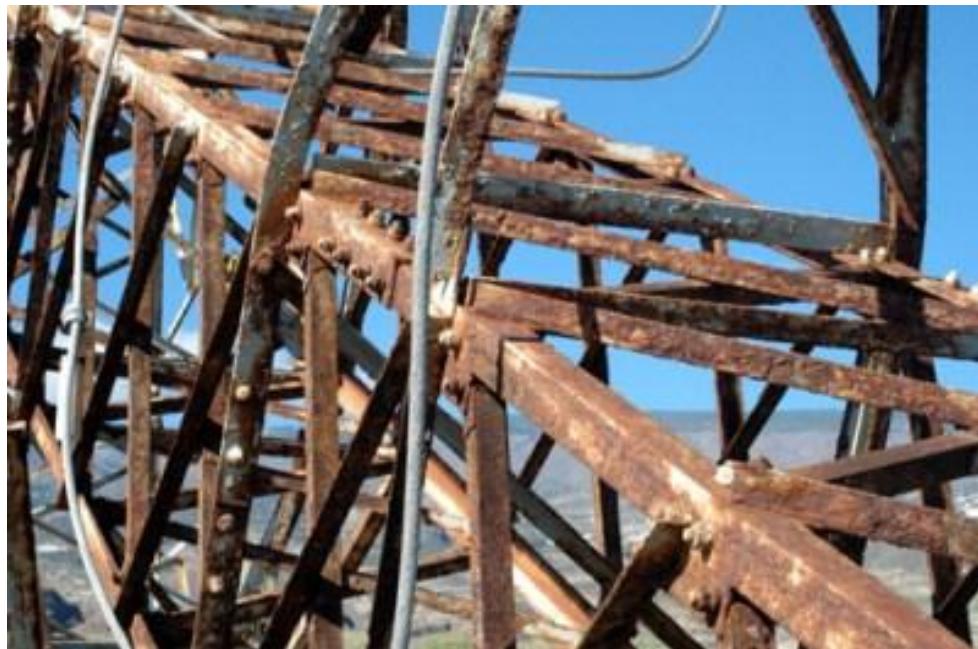
Figure 94 Extreme rusting in a steel lattice transmission tower<sup>68</sup>

- Rusting: towers are built with high quality steel and they may have anti-rust coating, but nevertheless they should be checked for rusting, especially near coastal areas, Figure 94.
- Grounding: the grounding cables should be checked in order to ensure proper protection against lightning.
- Check for damaged or weak foundations. This includes checking for possible permafrost melting, particularly in Nordic countries.
- Check and clear birds' nests: big birds such as storks have quite long wingspans and they can easily cause short-circuits.

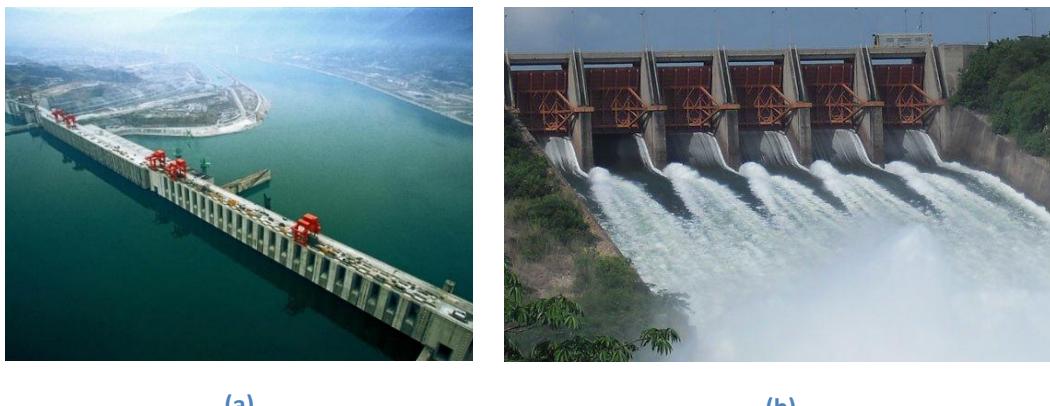
Figure 95 Three Gorges Dam (a)<sup>74</sup> and Akosombo Dam (b)<sup>75</sup>

- The "Three Gorges" dam in China, Figure 95a, which is 185 meters high and 2.3 km long,
- The "Akosombo" dam in the Volta River, Figure 95b, which was built between 1961-1966 and has a length of 700 m and a height of 134 m.
- In Europe, there are also important dams like the "Alqueva Dam" with 4150 hm<sup>3</sup> capacity, "La Serena" with 3219 hm<sup>3</sup> and "Alcantara" with 3160 hm<sup>3</sup>.

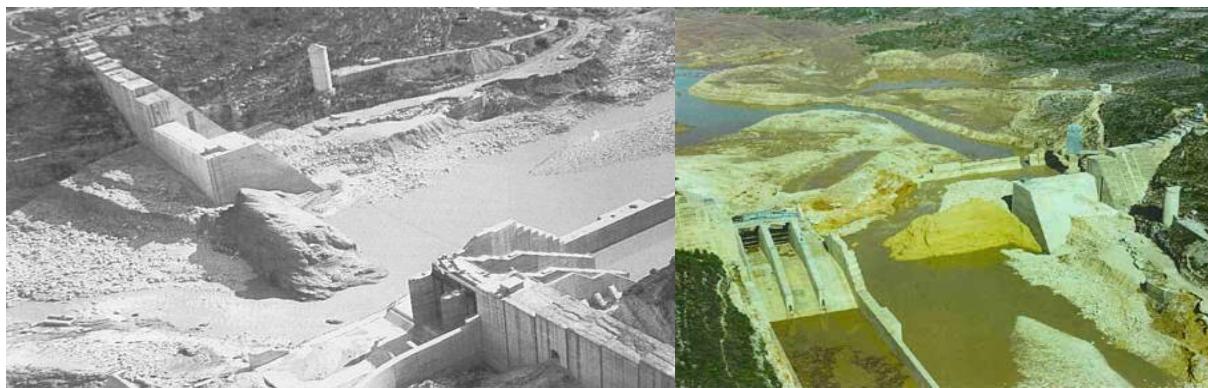
Figure 97 Tous dam breakage<sup>77 78</sup>,

As a result of the above, the water level rose in the dam by 20 meters in a mere 12 hours, reaching the dam crest. This was despite the last minute opening of the floodgates. In addition the dam had an insufficient discharge capacity to cope with the unexpectedly high incoming flood. . The water overtopped the dam and, since it was a rock fill dam, water eroded the downstream slope causing a progressive breakage and finally, its collapse, at 19:15 pm. The downstream flood reached 16,000 m<sup>3</sup> / s, one of the largest recorded in Spain, devastating the regions of "Ribera Alta" and "Ribera Baja".

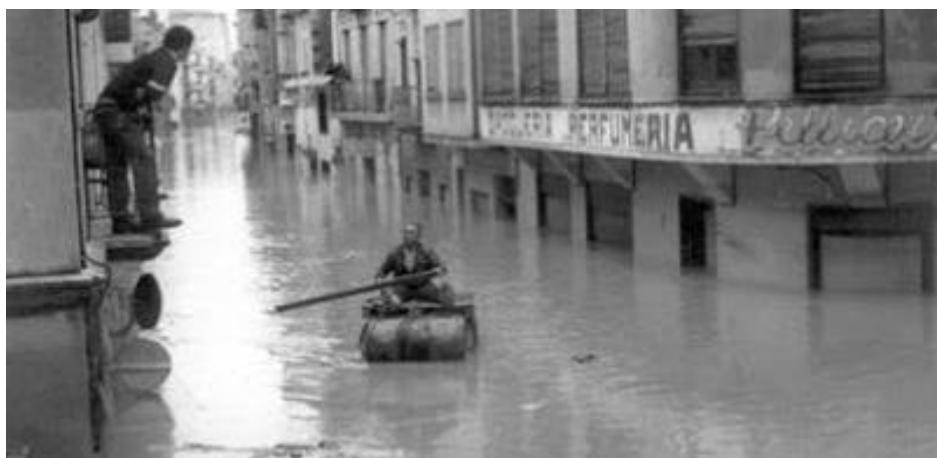
Figure 98 “La Pantanada de Tous”<sup>79</sup>

The nearest towns Figure 98 (Figure) reached a water level of eight meters causing structural damage in most buildings, generating economic losses estimated in 330 million Euros at that time and nearly 30 casualties.

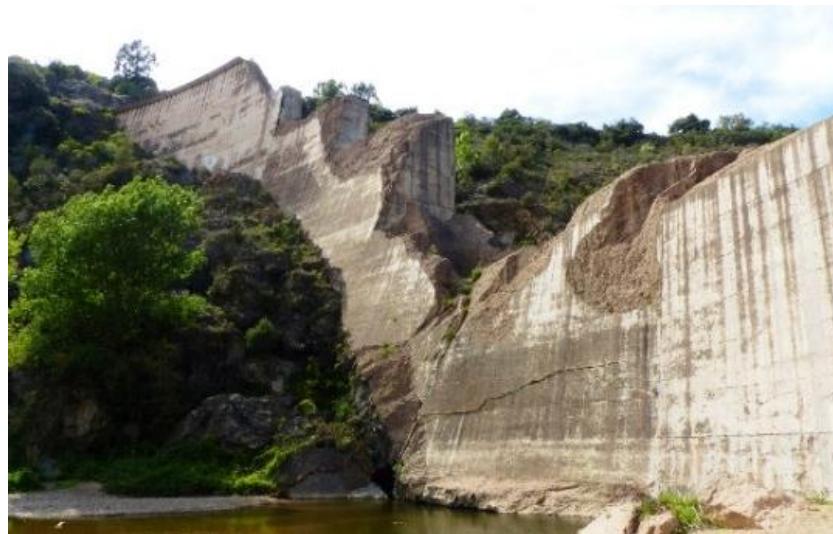
Figure 99 Malpasset dam<sup>80</sup>

Discharge valves were finally opened, but at a small rate, not enough to empty the reservoir on time. Water pressure in the foundation is also considered another cause for the disaster.

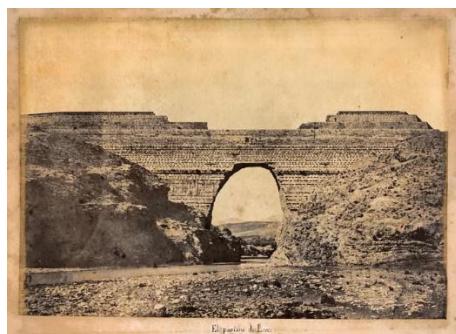
Figure 100 Second dam<sup>81</sup>

Years later, in 1785, the construction of the second dam, called "Puentes II", commenced. In 1802 the dam collapsed due to rains, floods and especially, a foundation failure. This failure was predicted by some engineers, as the dam foundation was located on sands, but the contractor responsible for the construction disregarded those negative reports. This collapse caused over 600 fatalities, the worst dam disaster registered in Spain.

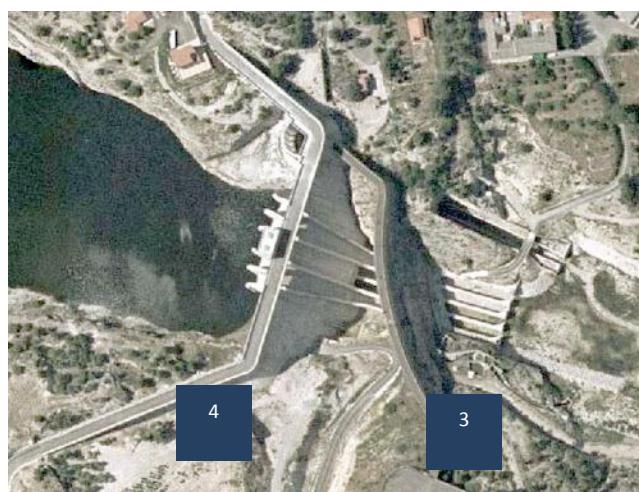
Figure 101 Third and fourth dam<sup>82</sup>

In 1881, the third dam (Puentes III) was built, located about 200 meters downstream away from the previous location, on a more suitable spot.

Finally, in 1993, a heightening project for Puentes III dam was approved, constructing Puentes IV in the same place, rendering the third dam redundant.

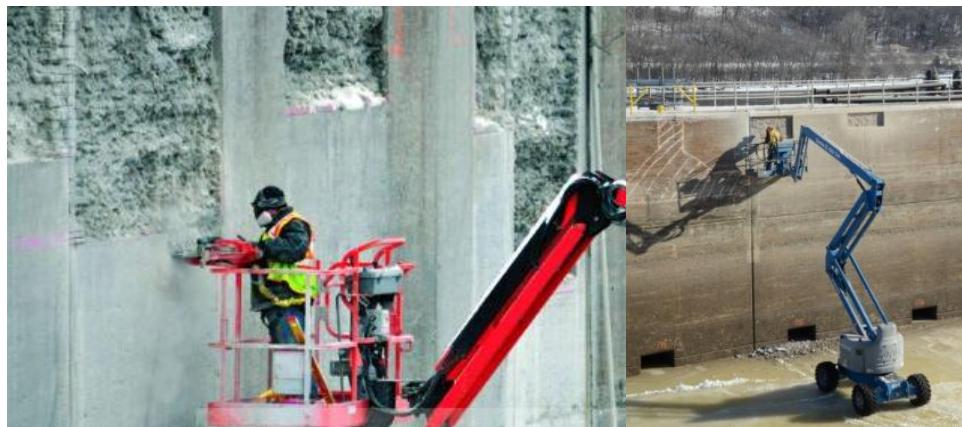
Figure 102 Joint and Cracking Maintenance<sup>83</sup>

The form of non-erodible structures (concrete, masonry, etc.) is unlikely to be particularly vulnerable to climate change, but there are exceptions, particularly at dams where existing climatic variation is known to cause problems associated with cracking or joint movement. Overflow structures and spillways may also be vulnerable due to increasing frequency and size of flows and catchment impacts that might increase debris and vegetation. Auxiliary structures such as valves or draw off towers may be vulnerable to similar effects and can be prone to other factors such as siltation or heat induced expansion.

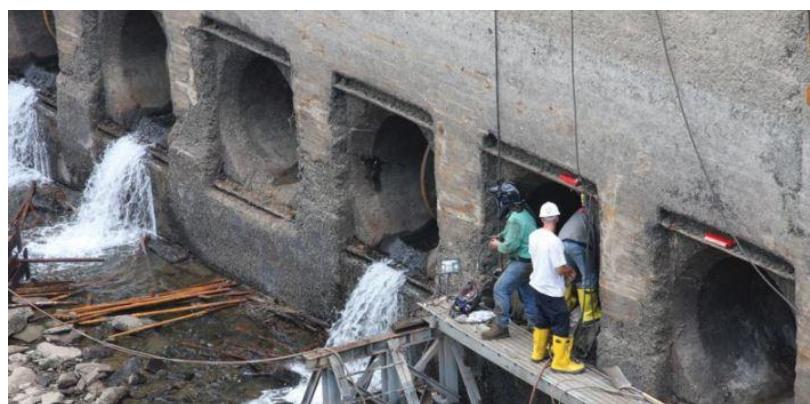
Figure 103 Valves maintenance<sup>84</sup>

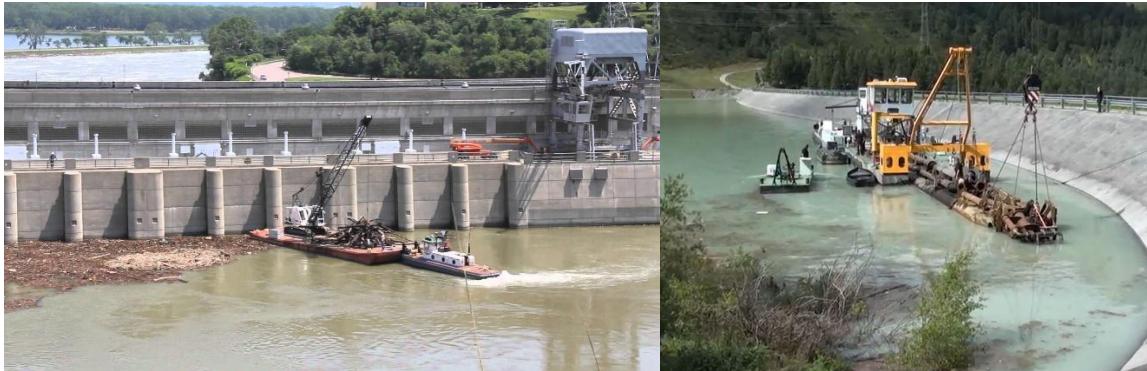
Figure 104 Maintenance operations (debris and vegetation removal and sedimentation dredging)<sup>85</sup>

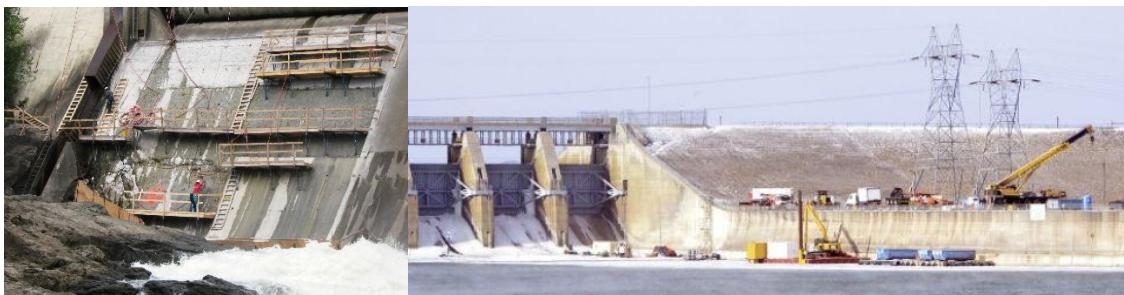
Figure 105 Spillway maintenance<sup>86</sup>
